Conditions Assessment, 15 May 2024

Hudson Public Library

Hudson, MA

Prepared by: Sorensen Partners | Architect + Planners, Inc., Westborough, MA
For: Hudson Public Library, Hudson, MA
Owner: Town of Hudson, MA

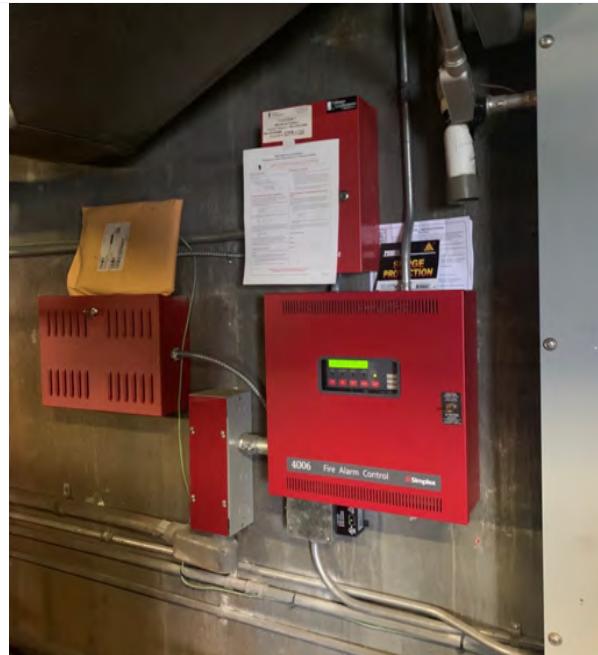
Simplex Fire Alarm control panel is located in the boiler room in the basement, below the 1966 Addition.

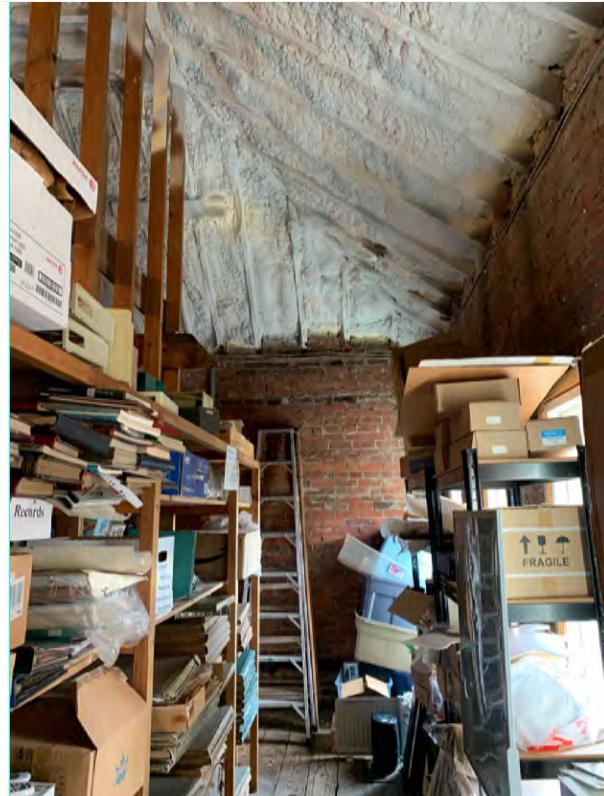
Any areas with combustible materials stacked higher than 8 feet, such as the circulation work room on the 1st Floor, should be assessed for fire risk.

Combustible materials higher than 8 ft and combustible spray foam insulation on the inside of Attic roof.

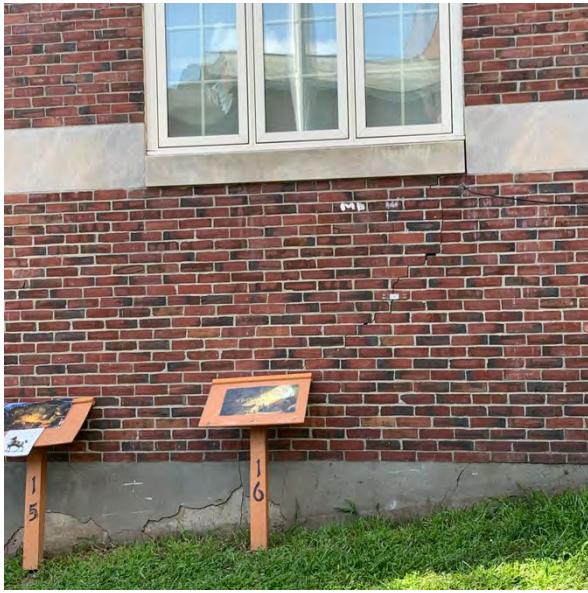
Cracks along 1966 addition side facing Liberty Park.

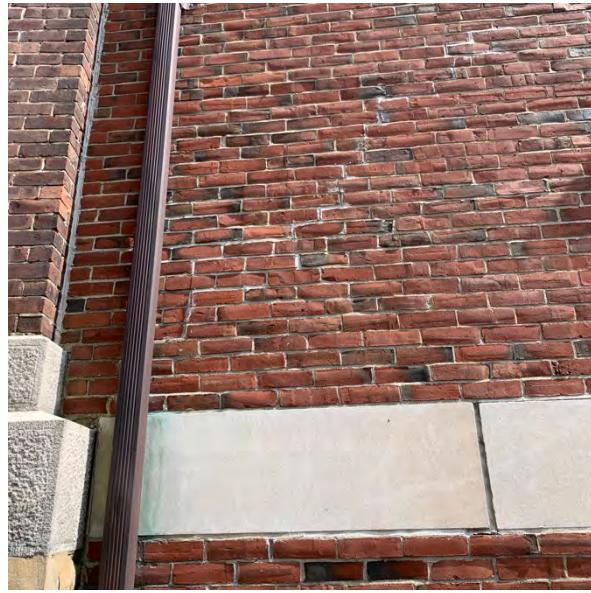
Cracks along 1966 addition side facing Town parking lot.

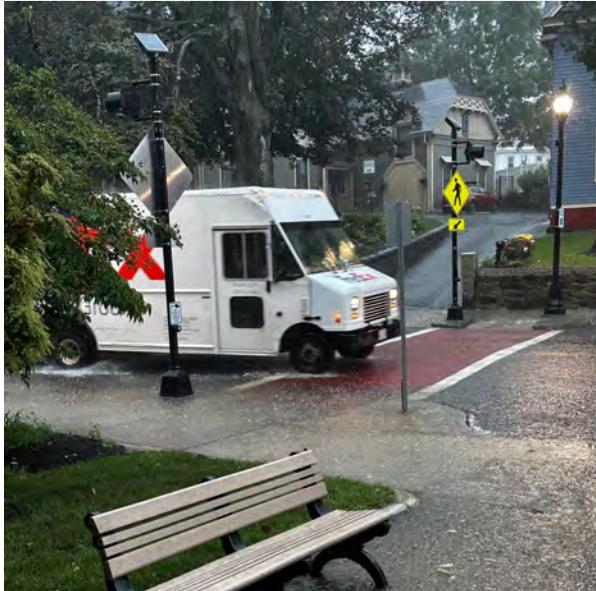
Water ponds at the crosswalk in front of the Library during storm events, causing an icy puddle, a potential slip hazard, in winter.

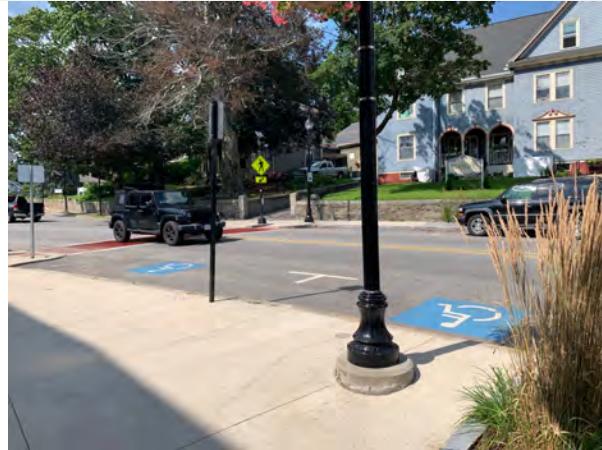
Two dedicated handicap-accessible parking spaces are located directly in front of the Library; however, they do not have a striped unloading zone leading to a curb cut to access the sidewalk, and they are therefore not code-compliant.

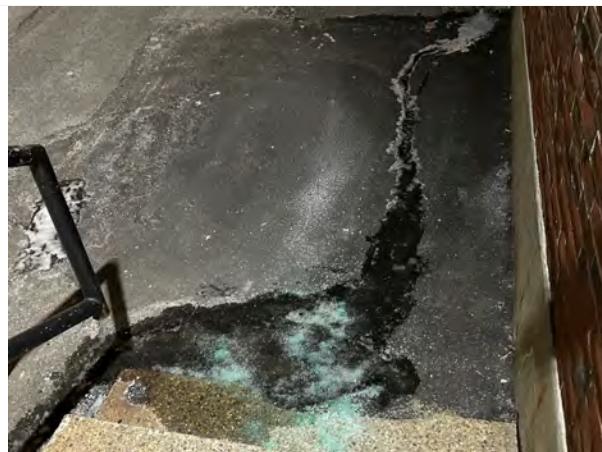
Slip hazard due to unplumbed downspout at staff entrance exterior stairs bottom landing.

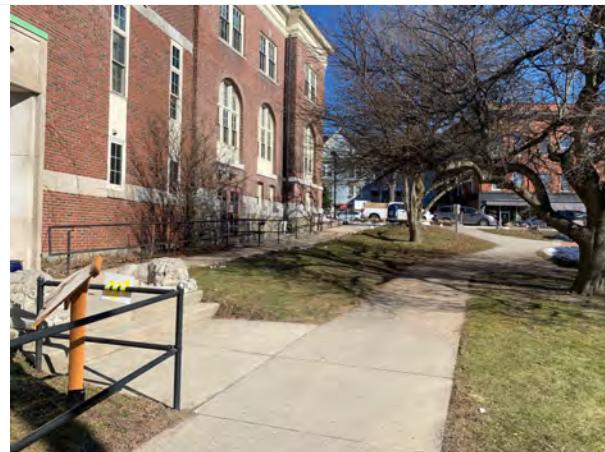
Ramp on the south side of the building designed as the handicap-accessible path of travel has too steep a slope to comply with code.

Uphill view of the non-code-compliant ramp on the south side of the building.

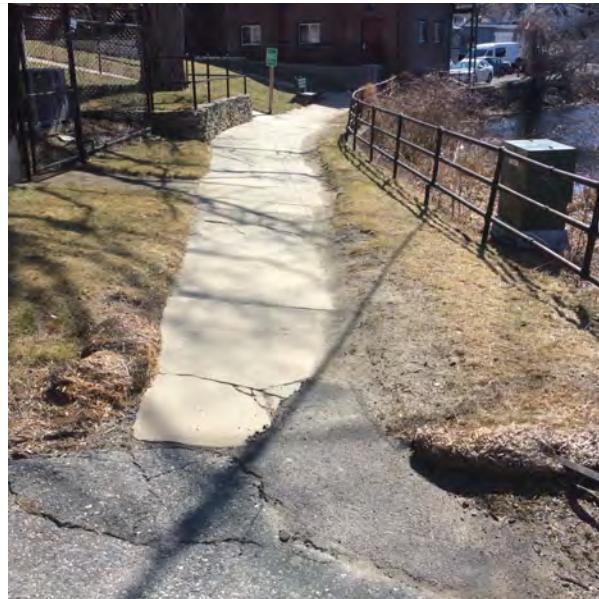
View from north of the cracked and uneven sidewalk used to access the Library from the adjacent public parking lot.

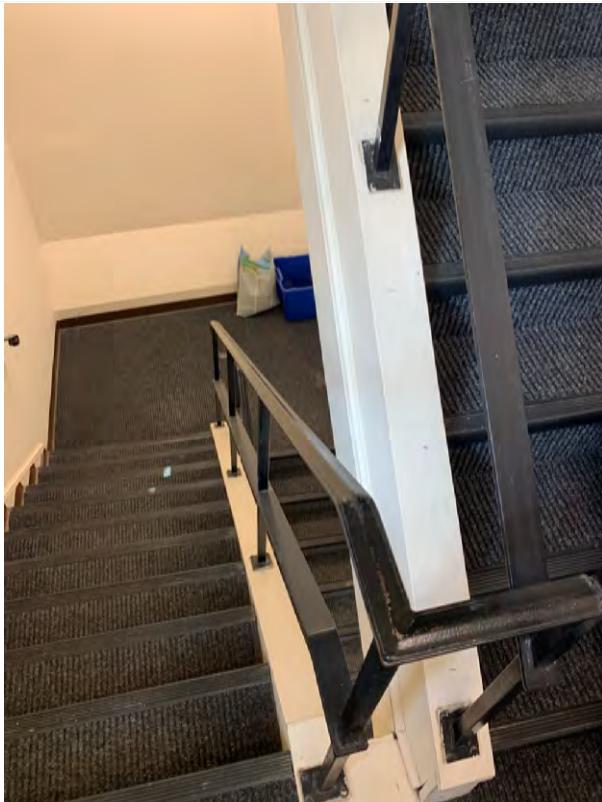
Handrails and guardrails in the egress stair tower do not meet current code.

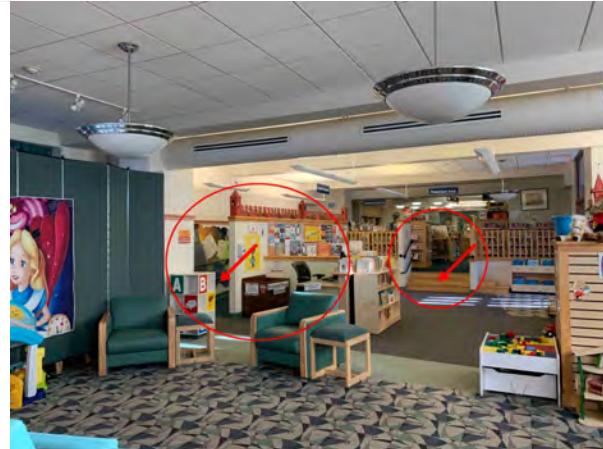
The Children's Room has an unnecessary flight of stairs that resulted in a need to add a ramp to provide handicap accessibility. The change in level is a historic condition based on the space's prior use as a civic meeting room.

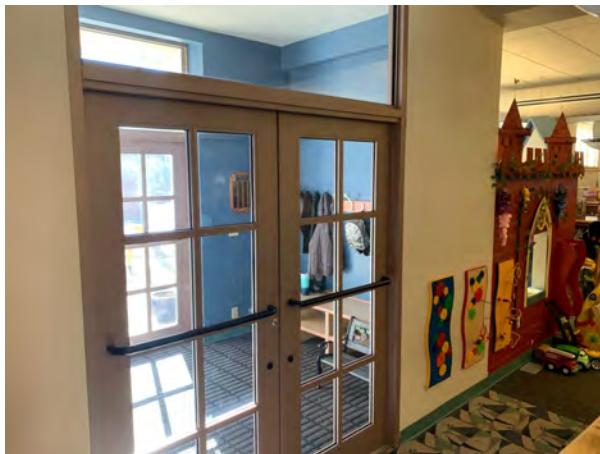
1. The vestibule of the second Children's Room entrance (the former civic meeting room entrance) is used as a coat room and for stroller parking, but it is not handicap-accessible.

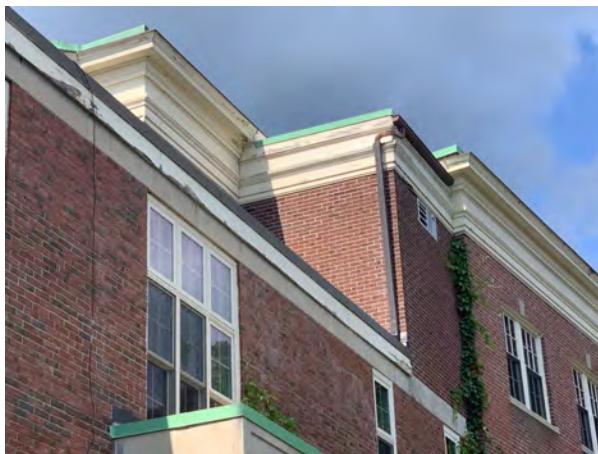
The wood fascias of both the Carnegie Building and the 1966 Addition have numerous areas of peeling paint, indicating rotted wood behind. Replacement of exterior wood trim is recommended to keep moisture out of the exterior walls and ceilings.

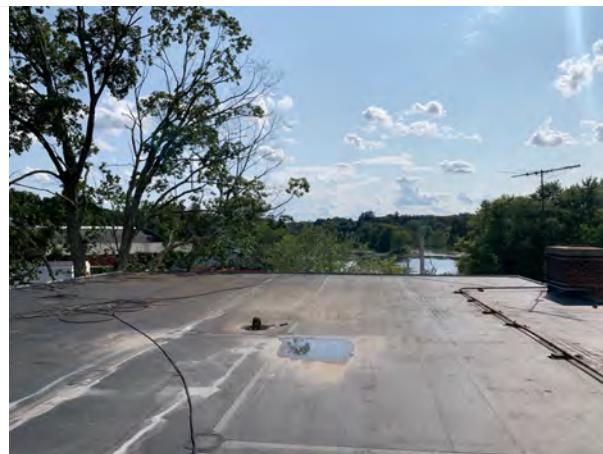
The roof of the 1966 Addition does not meet current code for amount of insulation nor number of roof drains required. A second roof drain is required by current code for a roof of this square footage. This rooftop is used as the location for two air conditioning condensers, which should be removed and reinstalled with correct curbs, flashing, and weight-spreading supports.

The roof of the 1966 Addition has a single roof drain, which does not meet current code (2 drains are required for a roof of this area).

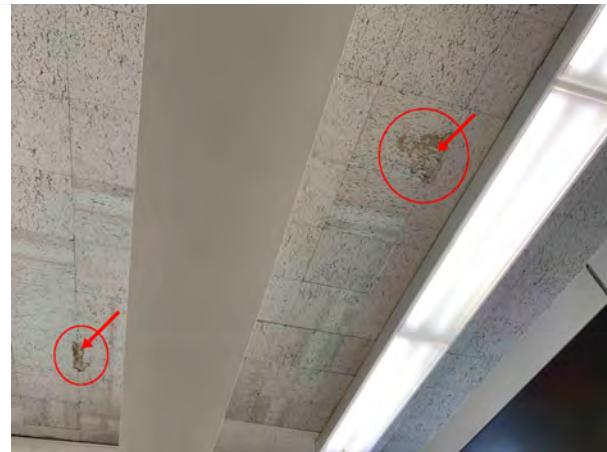
Evidence of roof leaks in the ceiling of the 1st Floor, 1966 Addition.

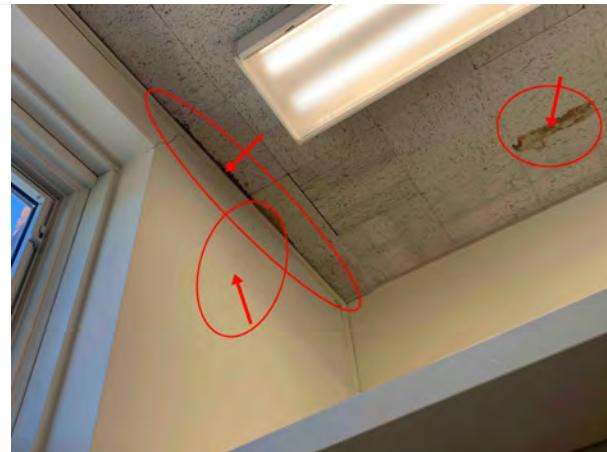
Evidence of roof leaks in the ceiling of the 1st Floor, 1966 Addition; these leaks have also affected the top of the wall, causing bubbling of the sheetrock.

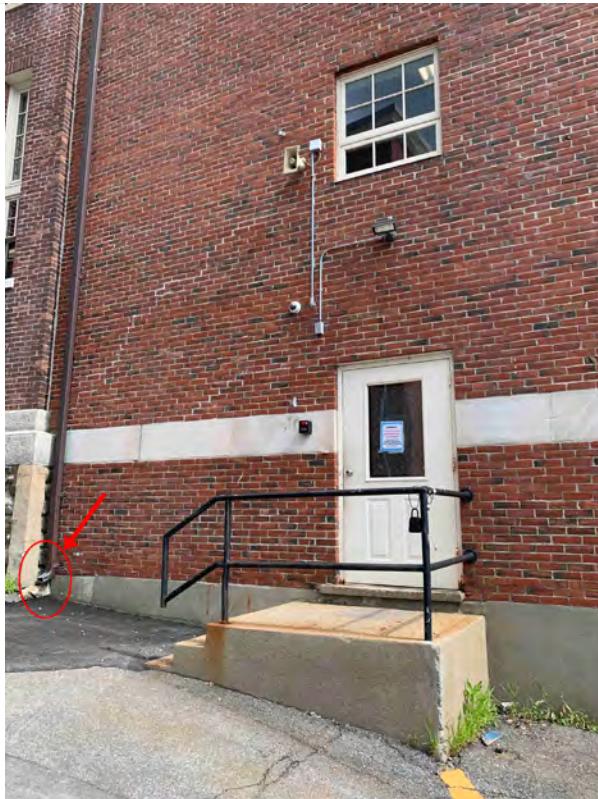
drainage. Its overflow results in sheeting and ponding frozen water across the parking lot and at the bottom stair landing of the staff entrance (which doubles as the egress stair exit). This is a slip hazard that should be addressed immediately in order to safeguard the public health, safety, and welfare.

Staff entrance. Image shows downspout is not plumbed to subsurface drainage, leading to a slip hazard due to ponding water at stair bottom landing.

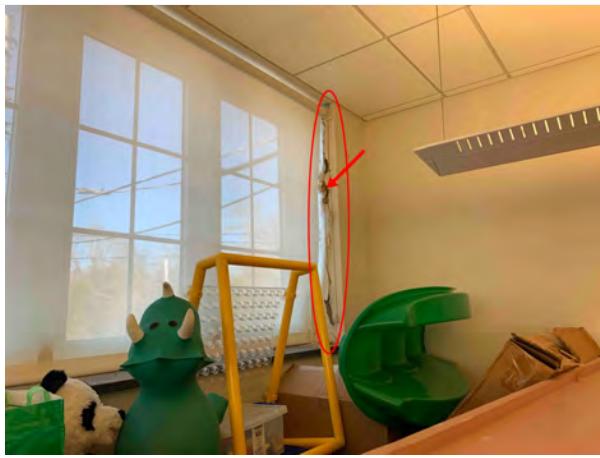
Active leak at Children's room Ground Floor rear window.

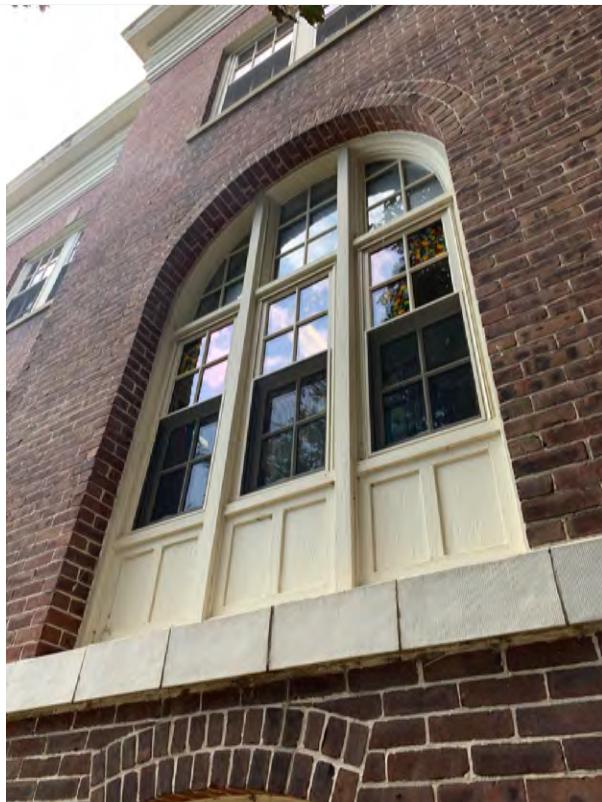
Replacement windows installed in 2010 in the Carnegie Building include painted wood panels, a maintenance concern, rather than durable factory-coated aluminum.

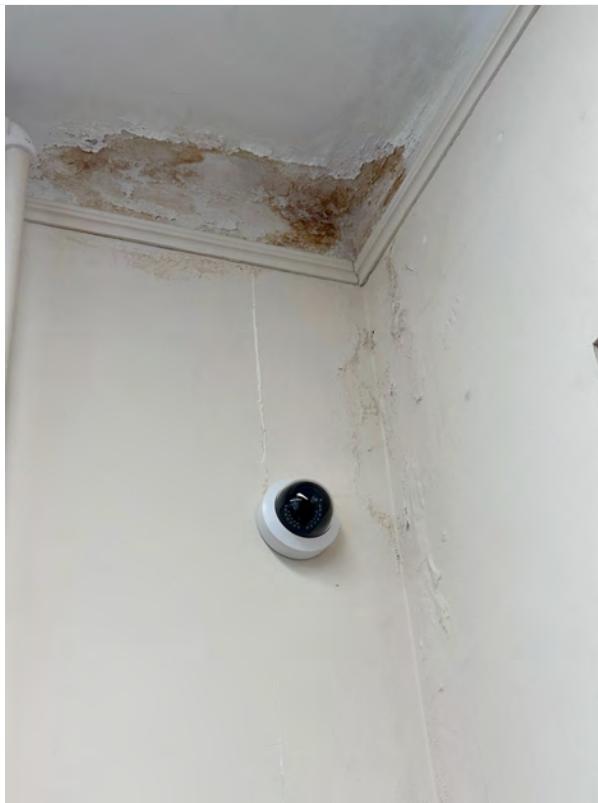
The brick walls of the southeast corner of the Carnegie Building's 1st Floor (teen space) have a persistent leak, causing peeling plaster at the interior.

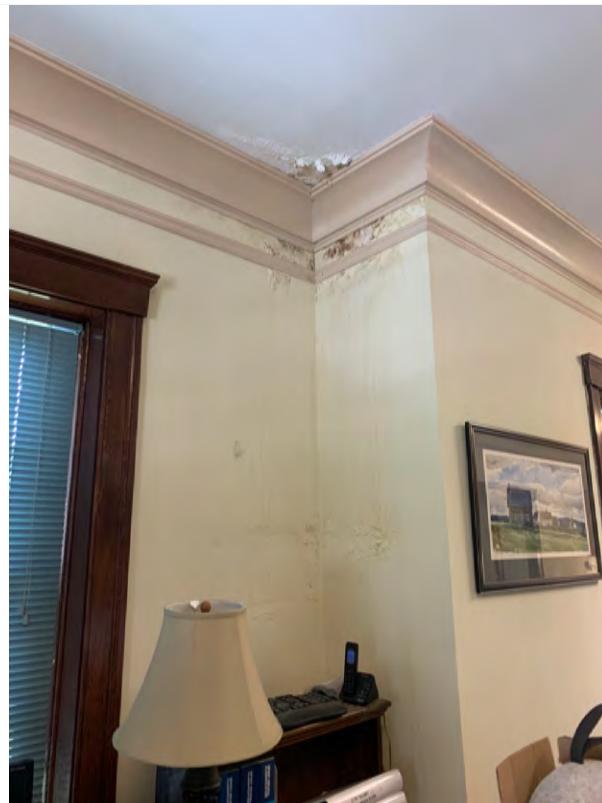
The brick walls of the southeast corner of the Carnegie Building's 2nd Floor (technical services offices) have a persistent leak, causing peeling plaster at the interior.

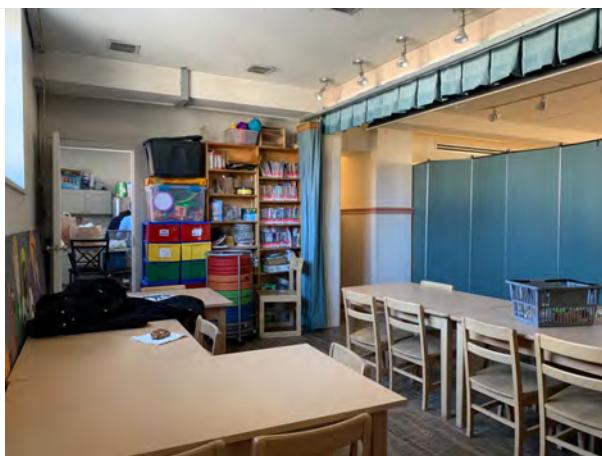
The craft room has an 18-inch drop-off to the floor below that lacks engineered fall protection.

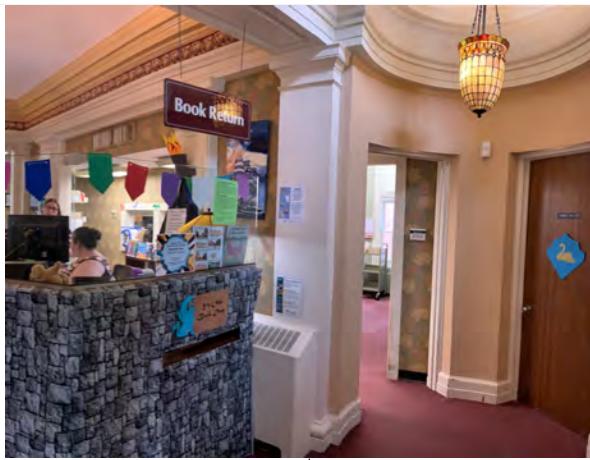
Interior doors on the 1st and 2nd Floor have round knobs that are not handicap-accessible.

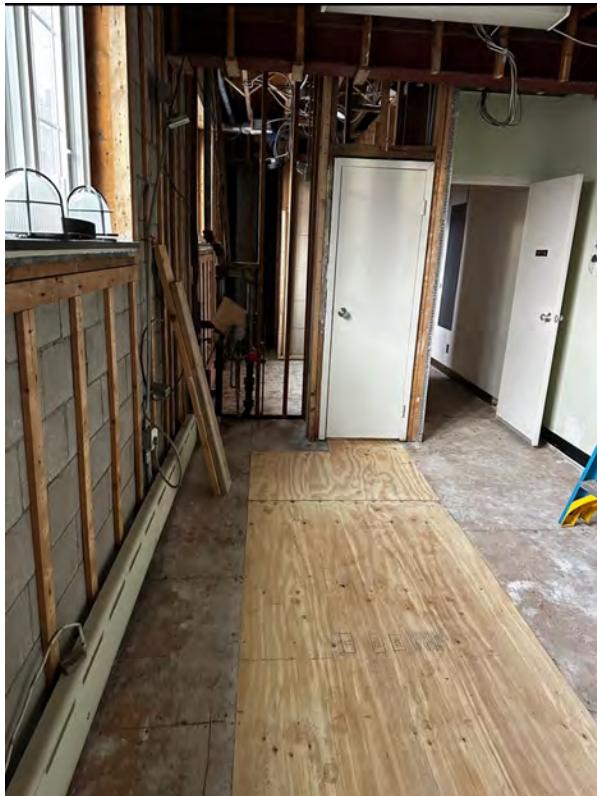
Extensive plumbing pipe replacement occurred for sinks and toilets during repair from the April 2023 steam pipe leaks. This was due to condensation filling wall and ceiling cavities and causing corrosion on plumbing piping.

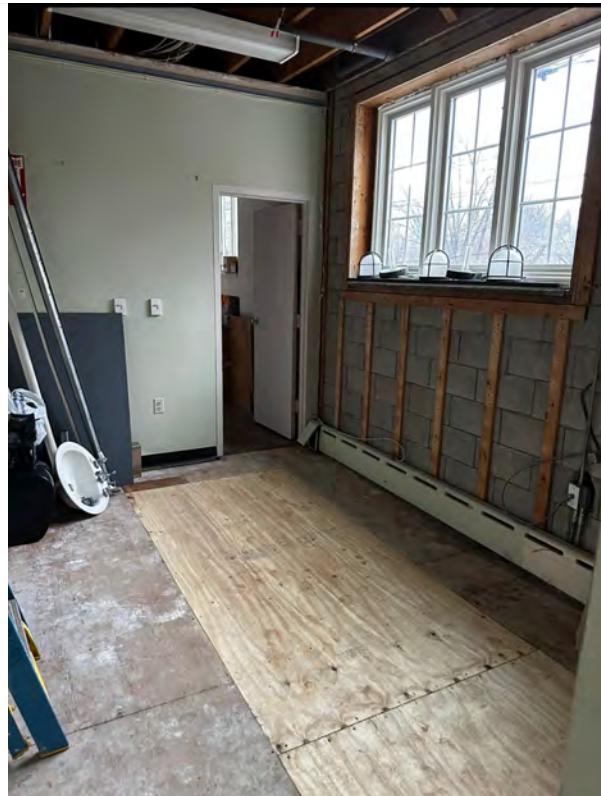
The contractor who replaced the cabinets in the staff kitchen due to the April 2023 steam pipe leaks found that the floor slopes 2 inches over 15 feet (due to uneven settlement of the building foundation).

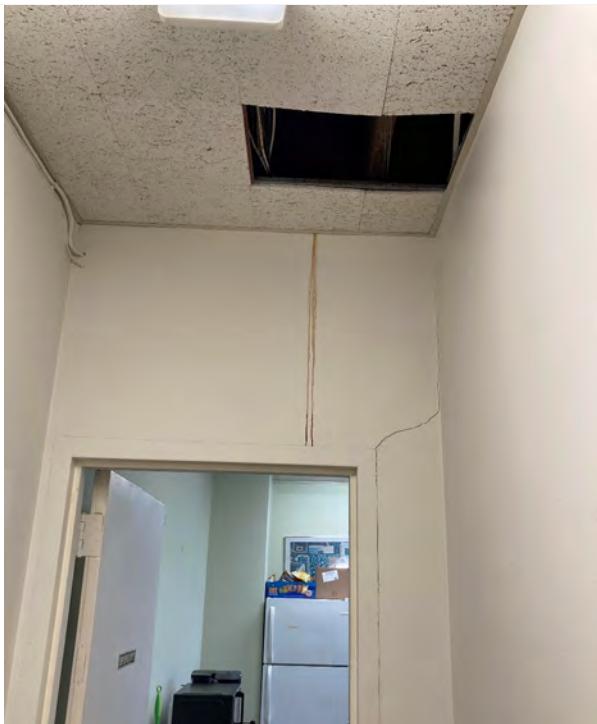
Steam pipe leaks at the Ground Floor concrete floor chase, resulting in steam buildup, mold and mildew in the staff area ceiling in April 2023.

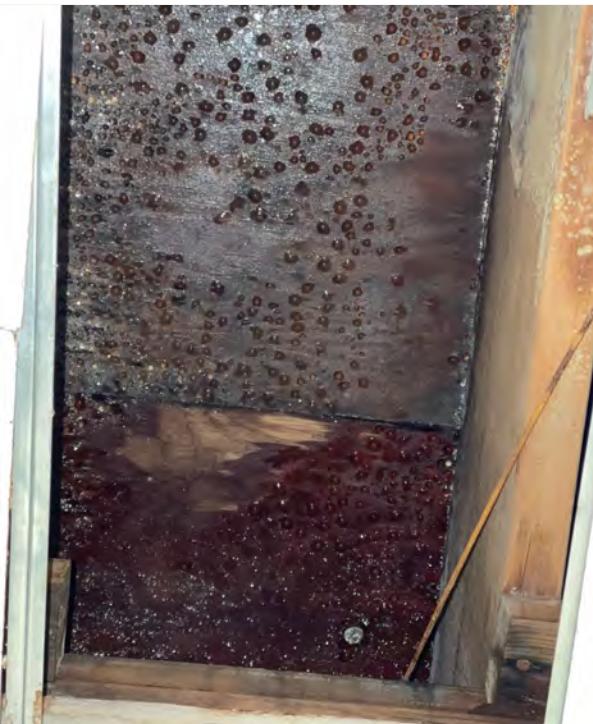
Steam pipe leaks at the Ground Floor staff area in April 2023 – resulting in showing condensation on plywood subfloor of staff area ceiling.

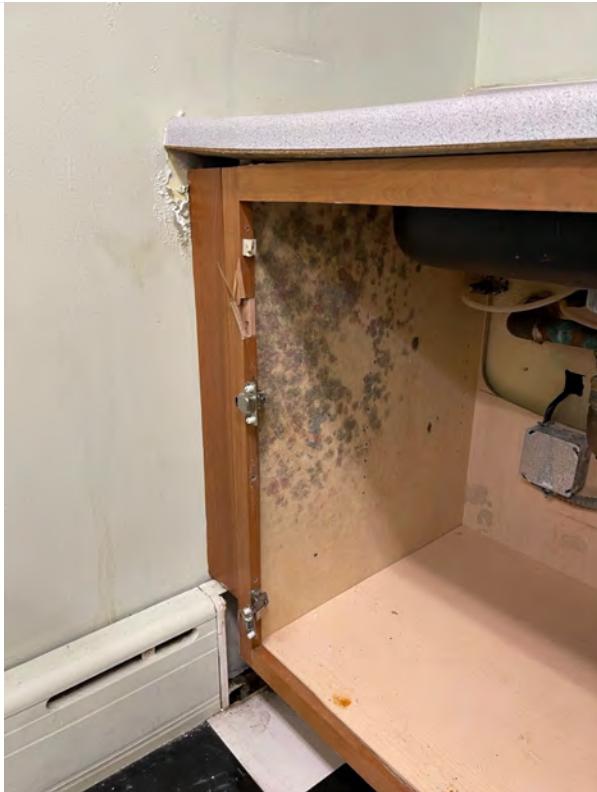
Mold was found on surfaces in the staff kitchen and restroom due to steam pipe leaks.

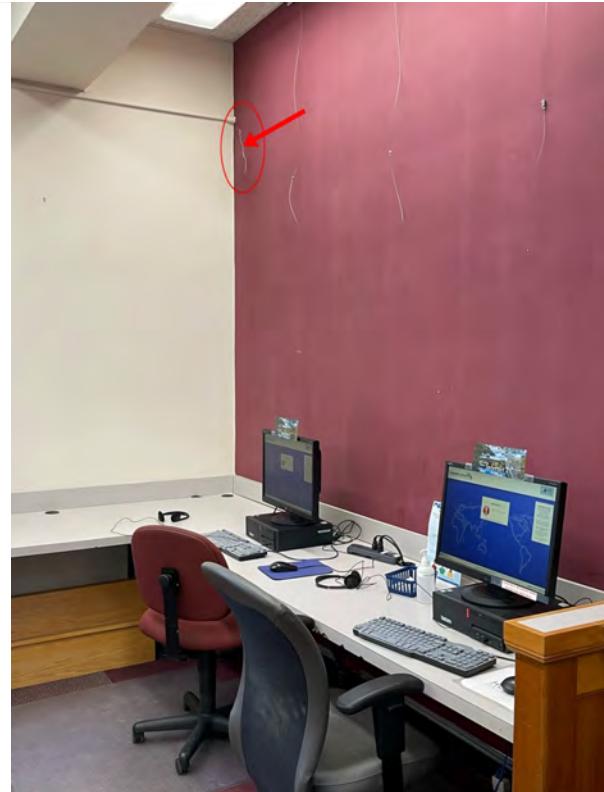
Plaster cracking at 1st Floor due to steam pipe leak at Ground Floor.

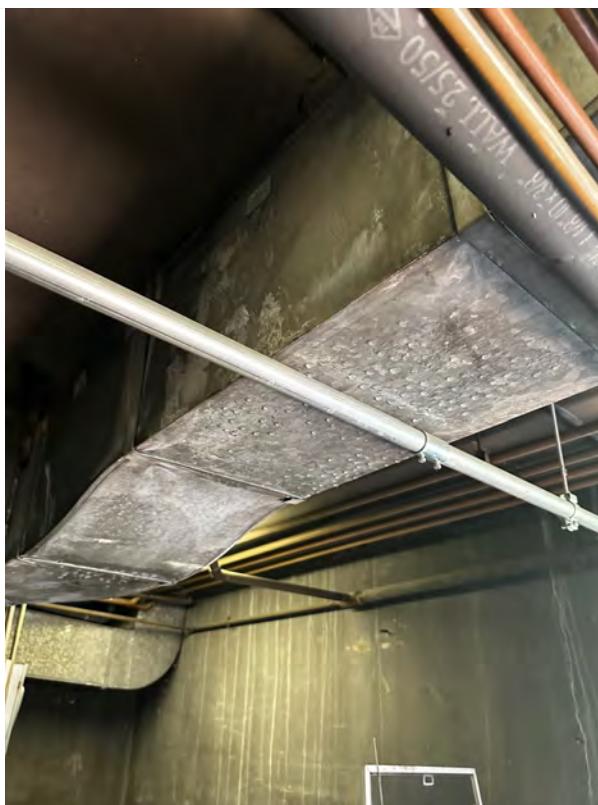
Condensation observed on July 20, 2023 on the surface of the unjacketed Zone 3 ductwork in the boiler room.

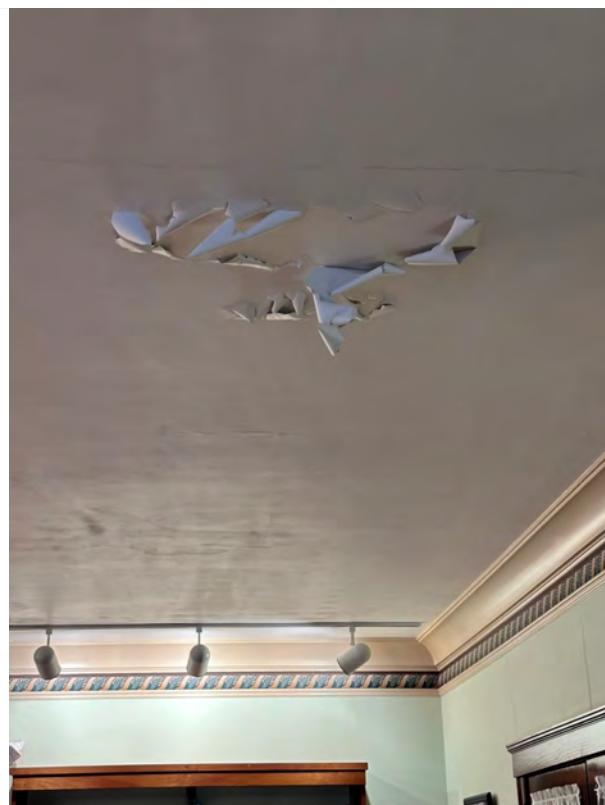
Peeling paint on the ceiling of the McLellan Room.

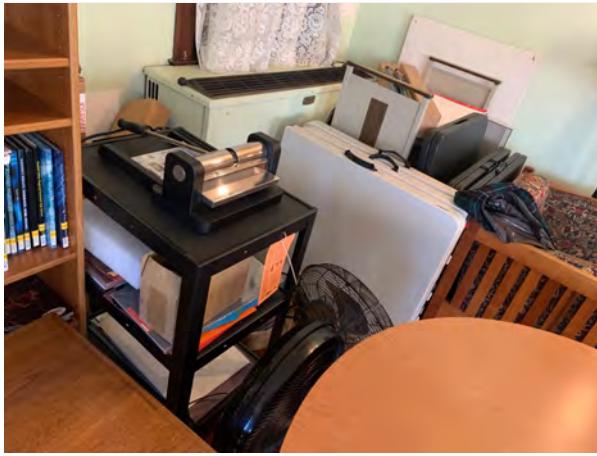
A UniVent forced air heater serves the McLellan Room. However this unit works intermittently and should be replaced.

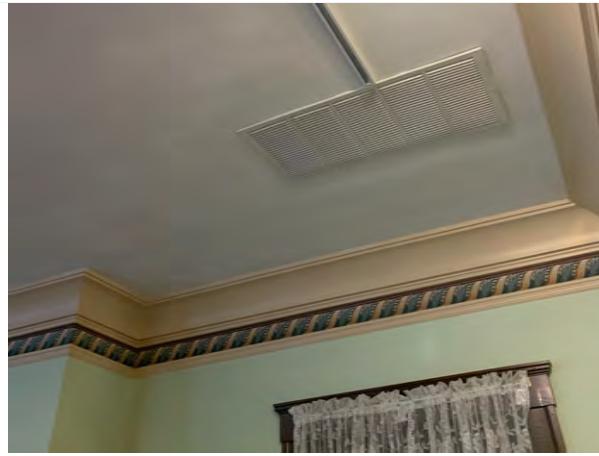
Air conditioning registers are located on the ceiling of the McLellan Room, directly below an AC unit. Too much cold air is delivered via the registers, and excess AC is directed to the circulation desk area below by conventional fans.

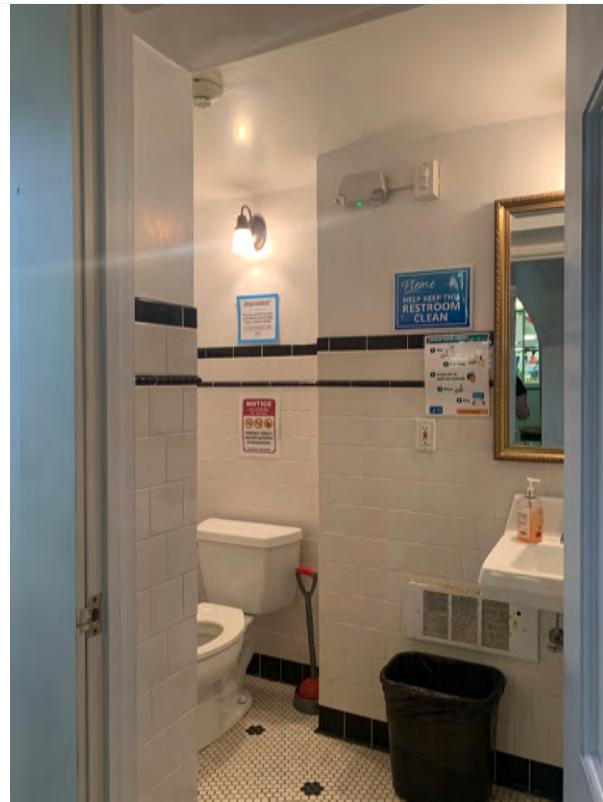
Interior view of typical bathroom below staircase. Clearances are tight; sewage backups are frequent; and signs of rust are present.

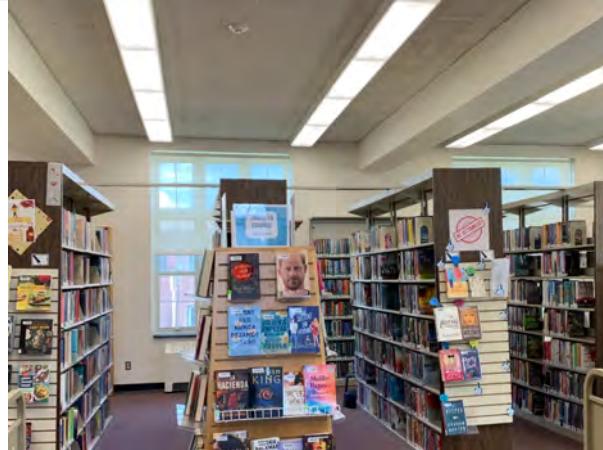
Rigid metal straps have been added on top of collections shelving on the 1st Floor for stability on the uneven floors.

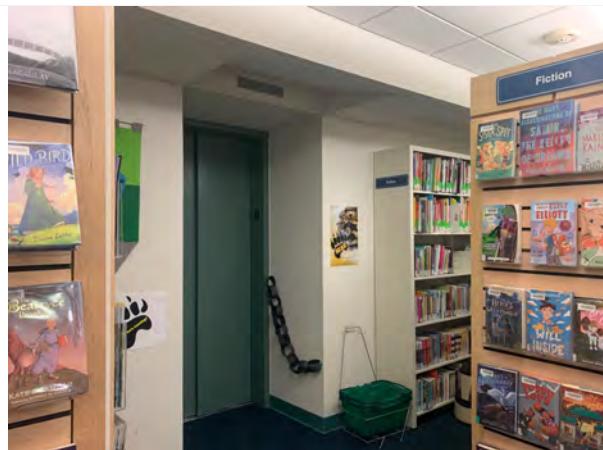
Ground Floor access to the elevator is constrained by nearby shelving which has been placed wherever space is available on the Ground Floor.
