Conditions Assessment, 15 May 2024

Hudson Public Library

Hudson, MA

Prepared by: Sorensen Partners | Architect + Planners, Inc., Westborough, MA
For: Hudson Public Library, Hudson, MA
Owner: Town of Hudson, MA

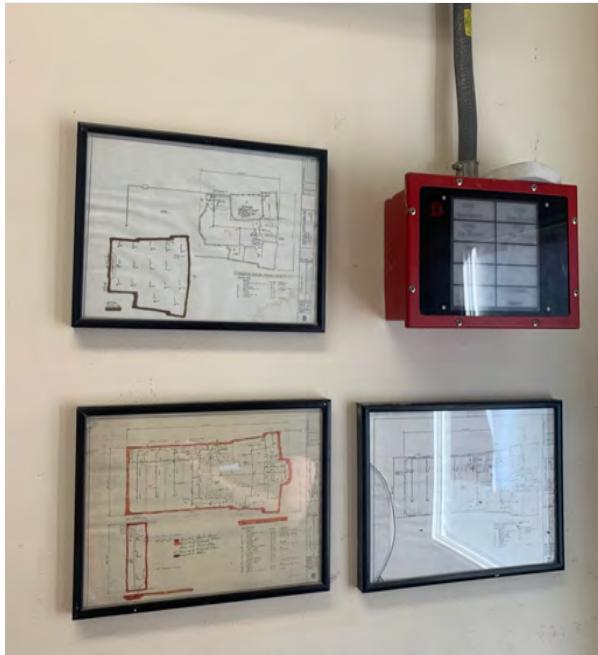
Fire Alarm indicator panel is located inside the door of the staff entrance on the north side of the building.

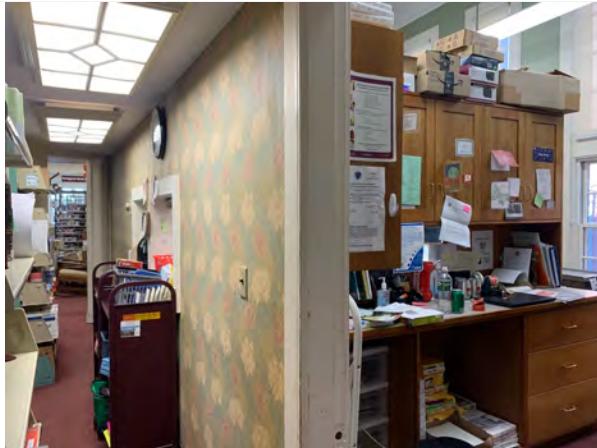
Any areas with combustible materials stacked higher than 8 feet, such as the circulation work room on the 1st Floor, should be assessed for fire risk.

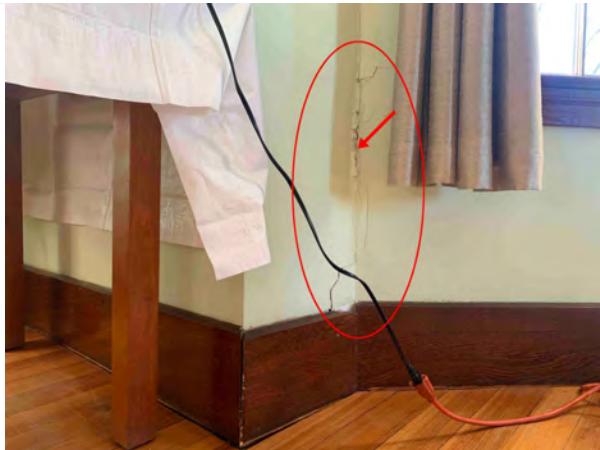
Cracking plaster indicates uneven settlement at the expansion joint for the 1966 Addition.

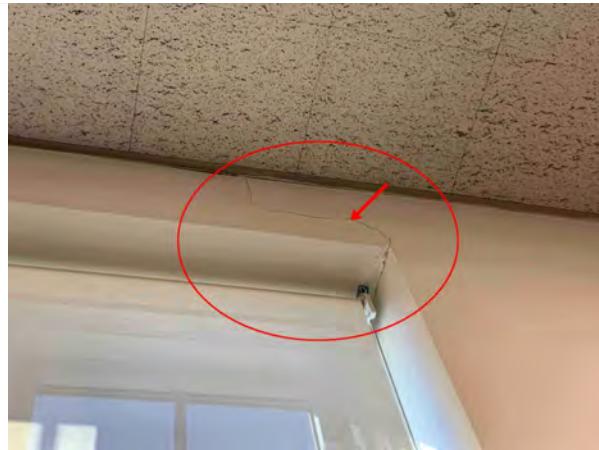
Cracking sheetrock wall at the rear of the 1st Floor. Cracking indicates uneven settlement of brick wall and foundations.

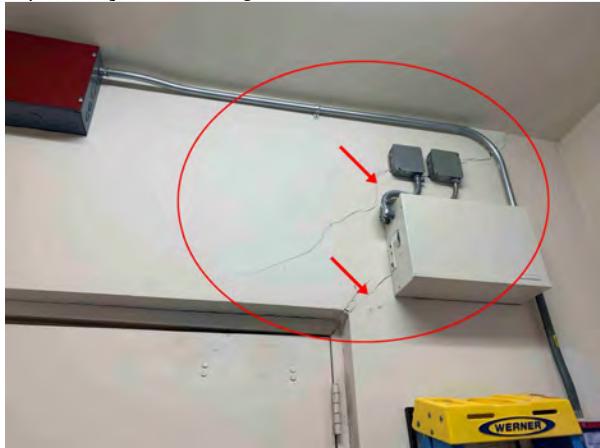
Cracking wall at the staff kitchen door leading to the boiler room, at the rear of the Ground Floor. Cracking indicates uneven settlement of brick wall and foundations.

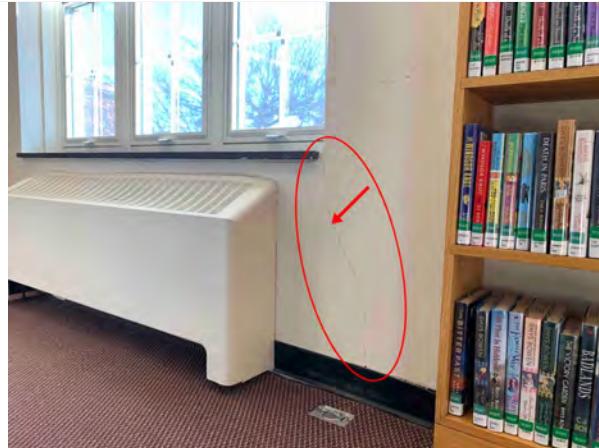
Cracking sheetrock wall at the rear of the 1st Floor. Cracking indicates uneven settlement of brick wall and foundations.

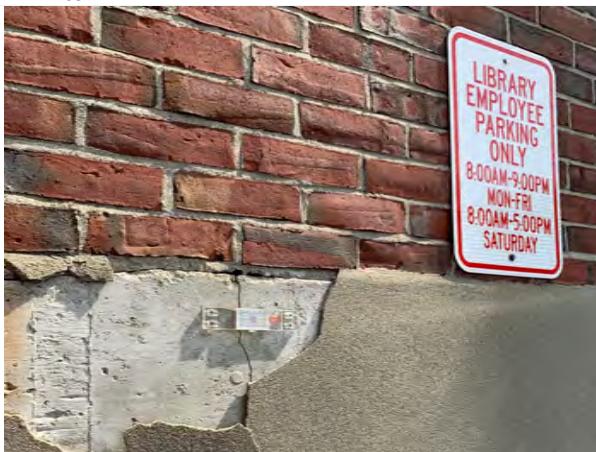
Staff parking is located on the north side of the building along a steeply-sloped parking lot.

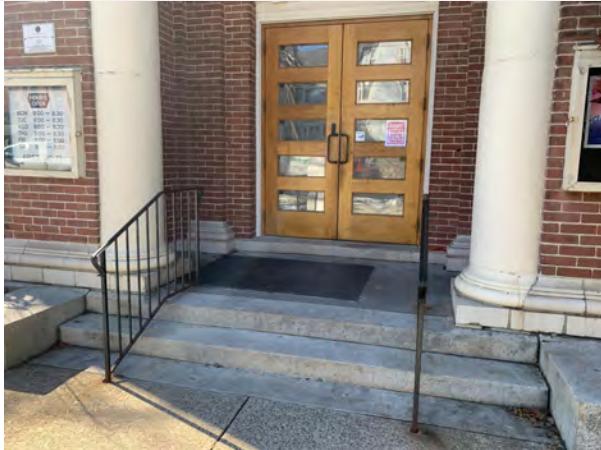
Main entry stairs and handrails are not handicap-accessible. Landings at the front doors are not code-compliant.

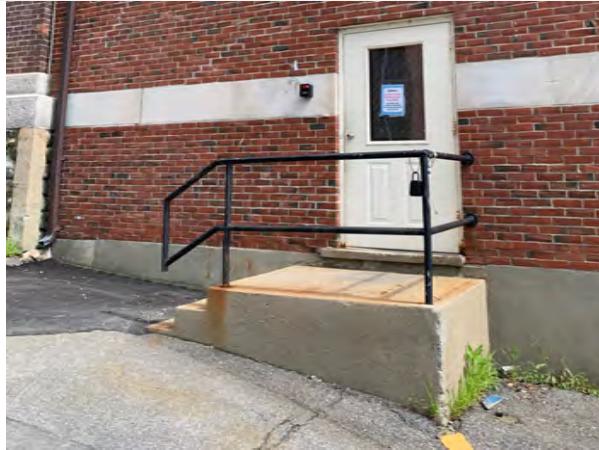
The staff entrance, located on the north side of the building, doubles as the exit from the emergency egress stair connecting all three floors of the building. Due to the differential settlement of this stair tower, the door can be difficult to open and there is a ponding water issue at the bottom landing. Handrails and stair treads and risers also do not meet current code at this entrance/exit.

Staff entrance doubles as the exit from the emergency egress stair that connects all three floors of the Library.

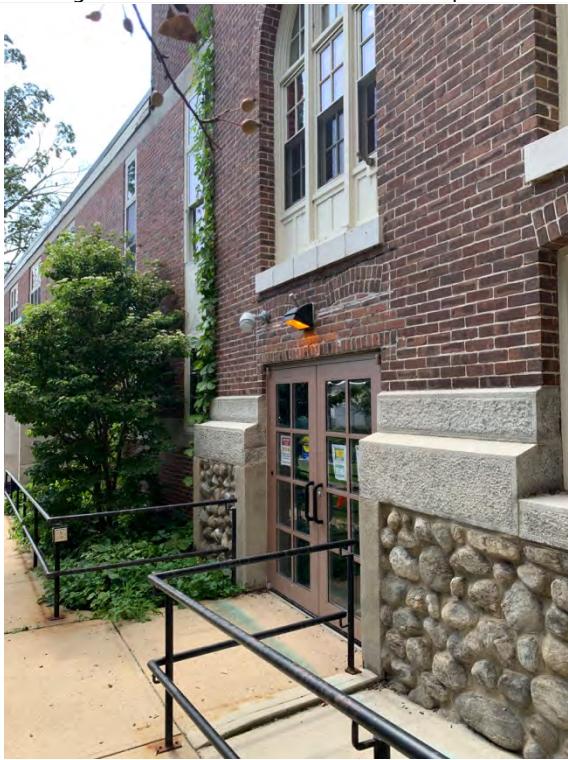
Ground Floor entrance on the south side of the building (designed as the handicap-accessible entrance but not code-compliant) leads to the Children's Room.

The designated handicap-accessible entrance is the uphill entrance on the south side of the building abutting Liberty Park, leading to the Ground Floor Children's Room. This entrance does not comply with current Massachusetts accessibility code which requires an equitable entrance experience for all visitors, including disabled visitors. The ergonomics of using this entrance

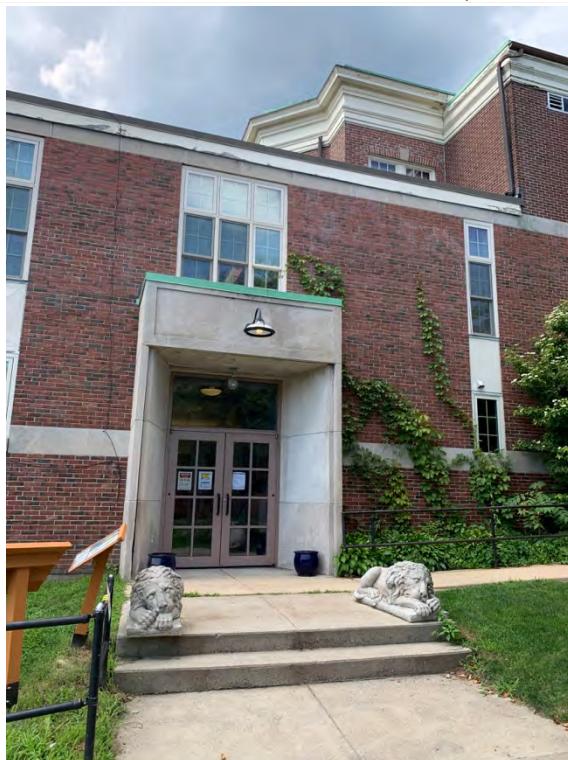
Children's Room second entrance at former civic meeting room; this redundant entrance is also located on the south side of the building.

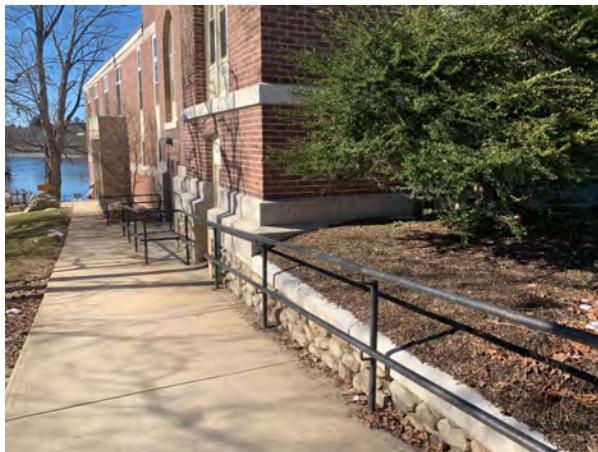
Ramp on the south side of the building designed as the handicap-accessible path of travel has too steep a slope to comply with code.

A code-compliant ramp requires a maximum 1:12 slope (4.8-degrees). The existing ramp on the south side of the building has a 5.3-degree slope and is excessively long relative to the location of the handicap-accessible parking spaces on Main Street. Furthermore, the existing ramp has handrails only on one side; whereas, code requires handrails on both sides of the ramp.

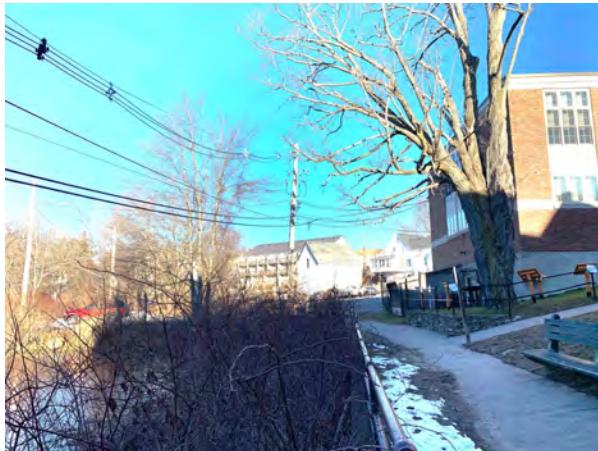
The Ground Floor entrance doors are the closest entry point for patrons accessing the Library from the adjacent Town-owned parking lot. However, the riverfront concrete walkway has a cross-slope that is greater than 2% and then slopes steeply upward at a 6-degree or more slope to intersect with the ramp infrastructure at the two south-side doors.

View of the uneven walking surface of the pedestrian walkway from the adjacent public parking lot, which leads to the bottom of Liberty Park, approximately 8 feet below the handicap-accessible entrance to the building.

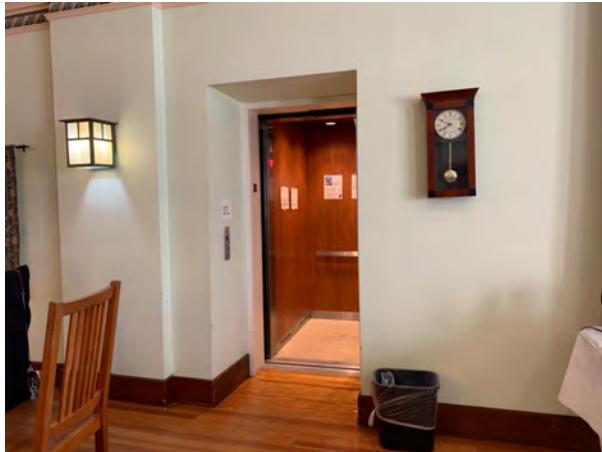
Elevator entrance opens directly into the quiet study room on the 2nd Floor.

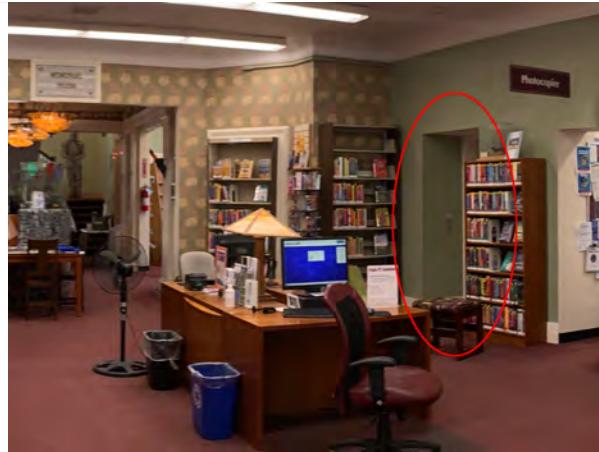
Elevator entrance on the 1st Floor opens into the adult services area.

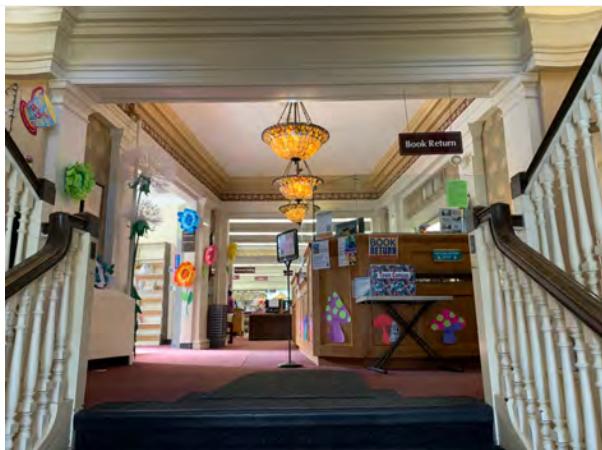
Inside the main entrance, climbing an additional set of stairs is necessary in order to reach the 1st Floor.

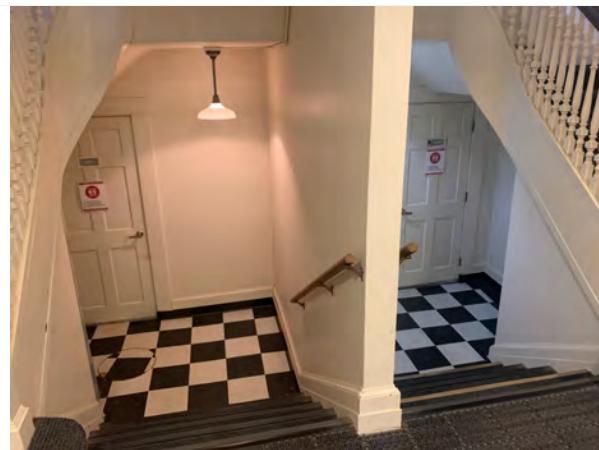
The historic front bifurcating staircase that connects the three floors of the building and the bathrooms is not code compliant in terms of the height of guardrails and the design of the integral guardrail-handrail, which is no longer permitted by code. The flight of stairs leading to the downstairs bathrooms below the Ground Floor lacks code compliant handrails on both sides of the stair.

Historic stairs to the bathrooms below the Ground Floor do not have compliant handrails.

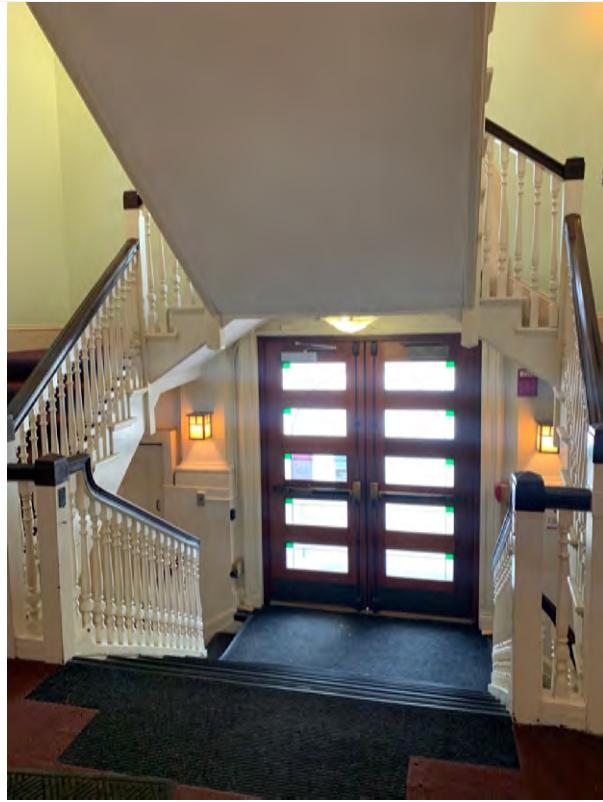
Historic stairs at the front of the Carnegie Building have non-code-compliant guardrails and handrails.

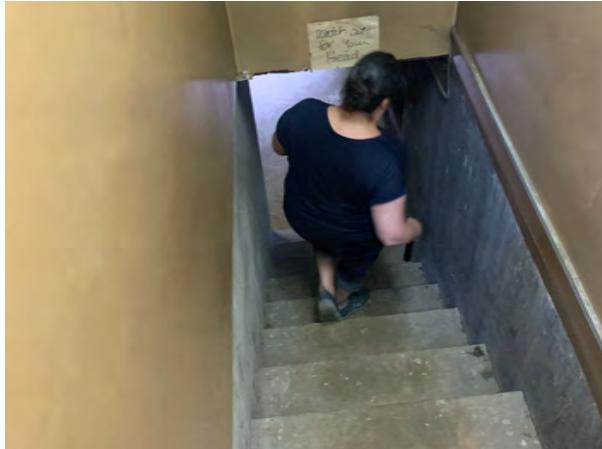
The staircase to the boiler room in the basement has no code-required handrails; and has insufficient headroom, which is a code violation and a safety hazard for technicians and Town personnel.

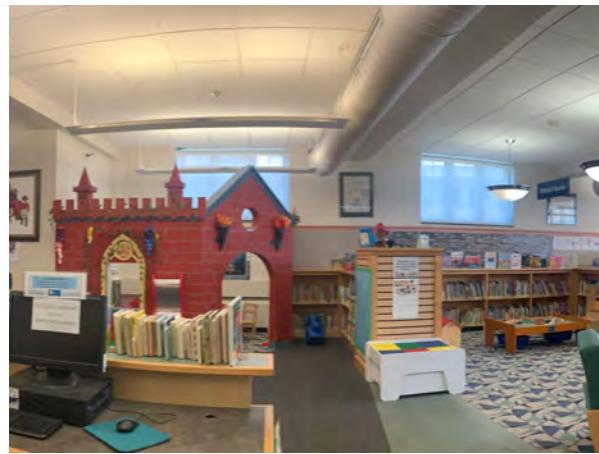
2. The fort in the Children's Room is not accessible to adult caregivers or persons with disabilities.

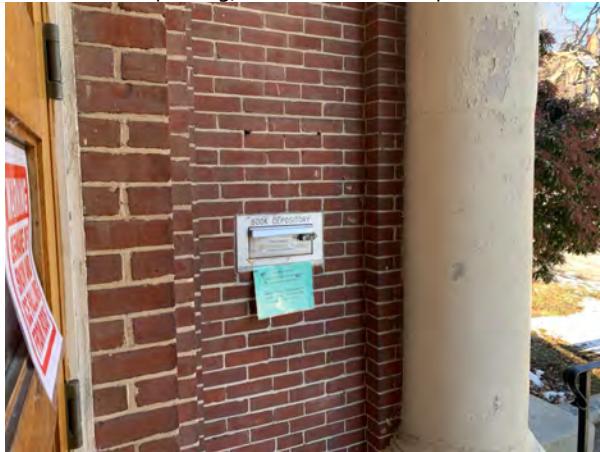
3. The book drop, located up a set of two stairs at the front entrance, is not handicap-accessible.

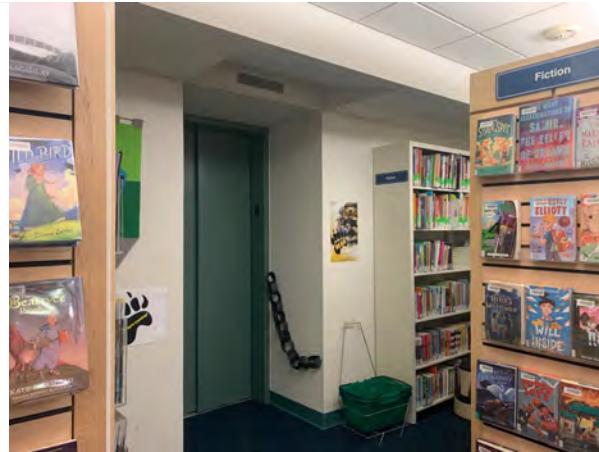
4. Clearances around the elevator on the Ground Floor are very tight, making access difficult.

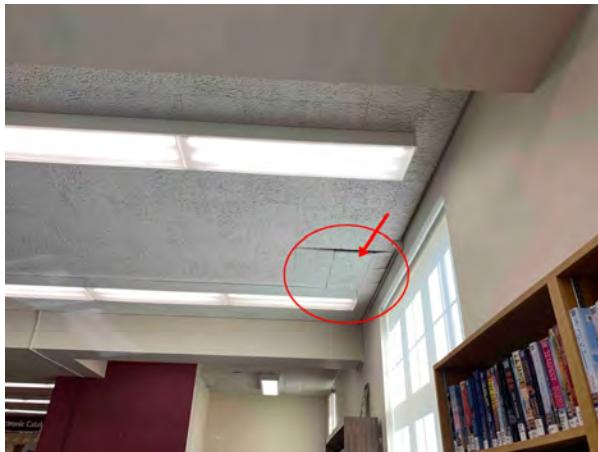
As can be seen in the images below, the interior of the 1st Floor within the 1966 Addition portion of the building is suffering damage to interior wall and ceiling finishes and has active leaks during rain events in the following locations reported by Library staff: near the reference area; behind the wall by the photocopier; near the checkers and scavenger hunt tables; and near the soffit by the column. The possibility also exists that mold buildup has occurred in the ceiling cavity of the 1966 Addition roof. Exterior views of this roof show that the wood fascia board has peeling paint and exposed wood areas, likely indicating rotted surfaces below. The wood fascia and flashing over it protect the top joint of the wall where it meets the roof and need to be covered in order to prevent water from entering the building. The recommendation to replace this roof as soon as possible includes replacement of the associated flashings and wood fascia.

Evidence of roof leak in the ceiling of the 1st Floor, 1966 Addition.

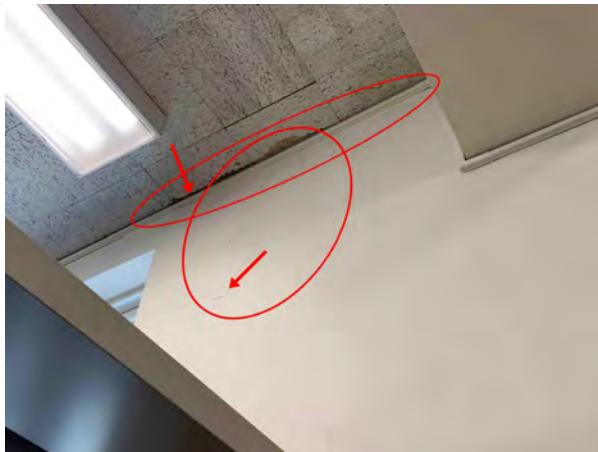
Evidence of roof leaks in the ceiling of the 1st Floor, 1966 Addition; these leaks have also affected the top of the wall, causing bubbling of the sheetrock.

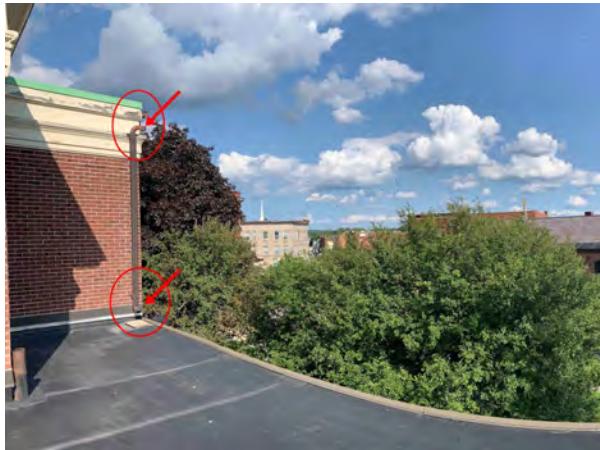
Several downspouts and roof drains from this roof enter the upper walls of the building with through-wall and through-ceiling penetrations and piping that are incompletely designed; this improper roof drainage has resulted in persistent condensation on the surface of internal drain pipes and some leaks that are still occasionally active. The entire roof, including the roof drainage system, should be re-examined to ensure all roof runoff is directed to gutters properly plumbed to downspouts and interior drainpipes with integrity from rooftop to sewer. The canopy at the main entrance should be included in this examination and repair project, since a sign warning of possible snow and ice falling is located at the front door.

Downspouts from the Carnegie Building roof are not correctly plumbed to drain onto the roof of the 1966 Addition without overflowing or leaking.

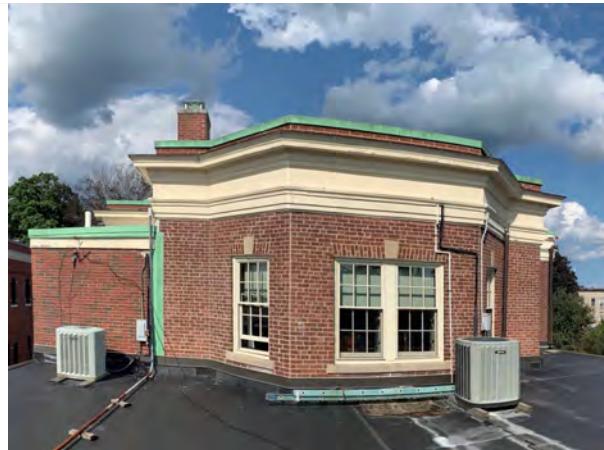
The roof of the Carnegie Building is a patina green-colored PVC membrane installed in 2010; deco-ribs added to the pitched areas make it look like a metal roof.

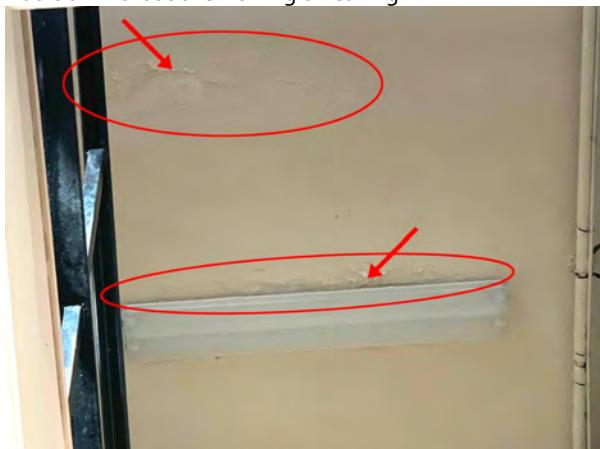
Peeling paint on the ceiling of the north exit stair tower is evidence of current roof leaks.

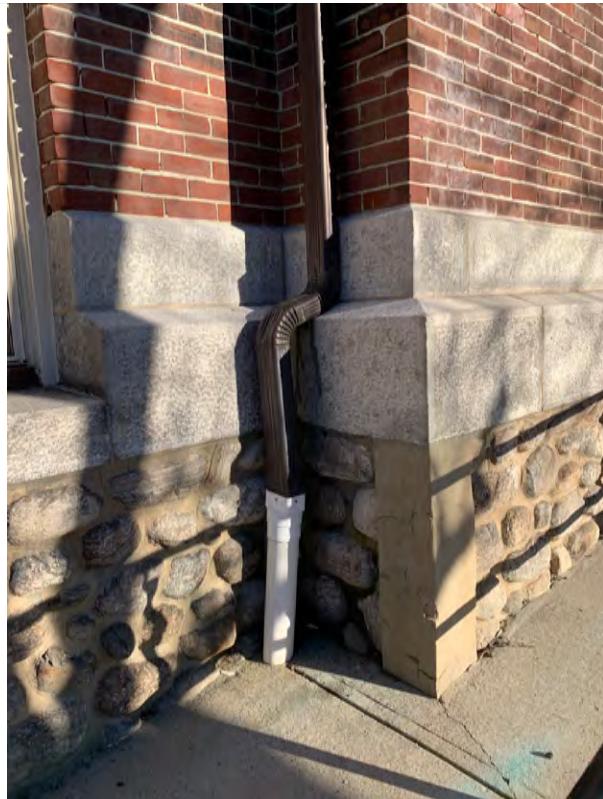
Some downspouts are correctly plumbed to storm piping such as this downspout on the south side of the building.

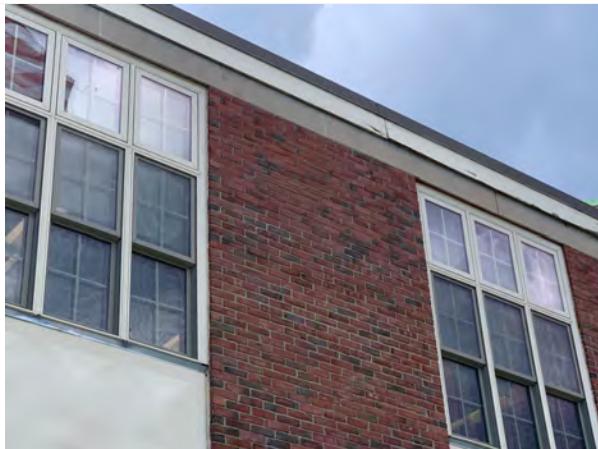
Aluminum windows installed in 2010 at the 1966 Addition.

Window and storefront installed in 2010 in the 1966 Addition are aluminum windows and storefront with insulated aluminum spandrel panels with insulated glazing units (IGUs) and chain-operated shades. Due to the differential settlement of the foundations, window surrounds throughout the 1966 Addition have hairline cracks emanating from the corners, indicating that caulk joints will continue to enlarge and prevent the window installation from being water-tight.

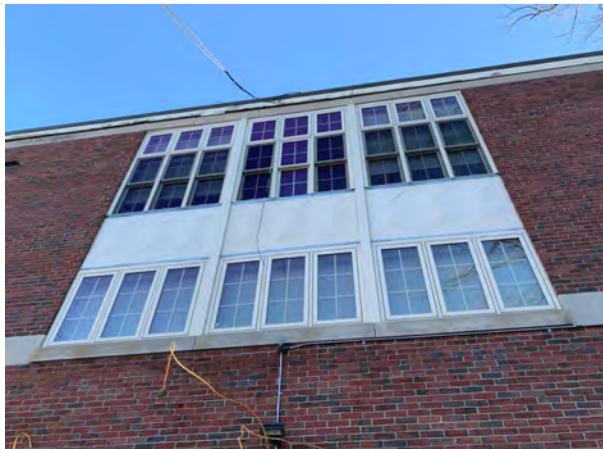
Aluminum storefront installed in 2010 at the 1966 Addition.

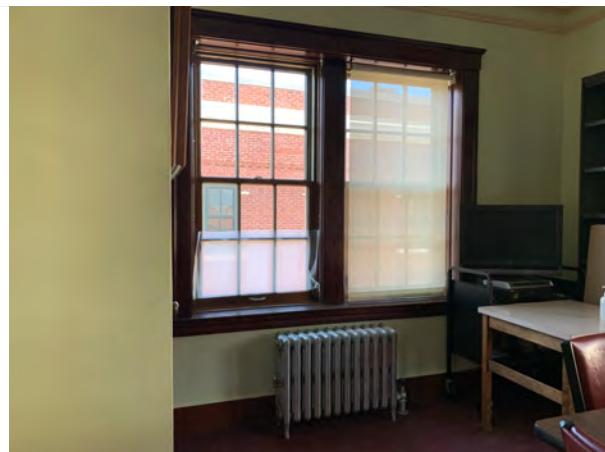
Typical interior view of a 2010-installed wood-wrapped replacement window in the Carnegie Building.

Windows installed in 2010 in the Carnegie Building are wood-wrapped divided-lite replacement windows with insulated glazing units (IGUs) and chain-operated shades. Replacement windows installed in 2010 in the Carnegie Building include painted wood panels (rather than durable factory-coated aluminum, the standard for commercial buildings), which is a maintenance concern. Chain-operated shades are no longer permitted by current code due to the possibility of strangulation from the chains. The Library should assess this risk and act accordingly to reduce or eliminate the risk based on its level of caution regarding this topic.

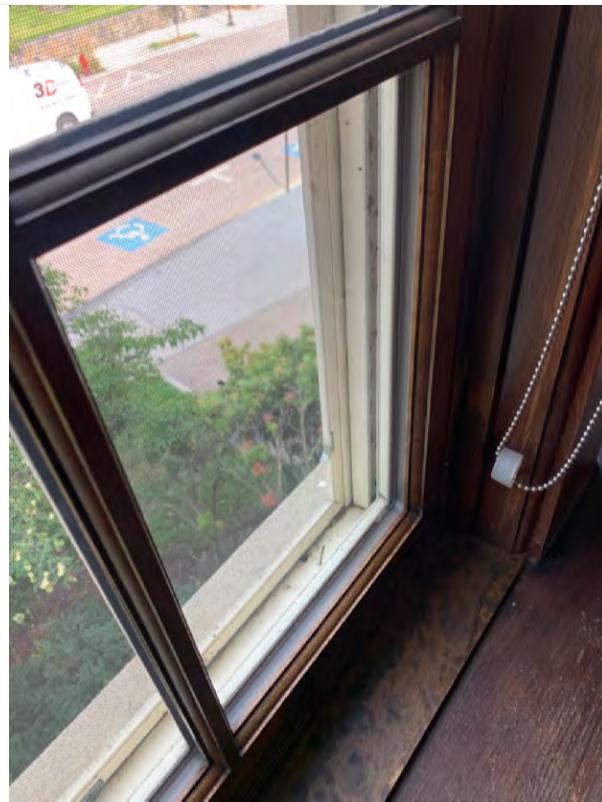
Windows in the Carnegie Building installed in 2010 are wood-wrapped divided-lite replacement windows with insulated glazing units (IGUs) with chain-operated shades.

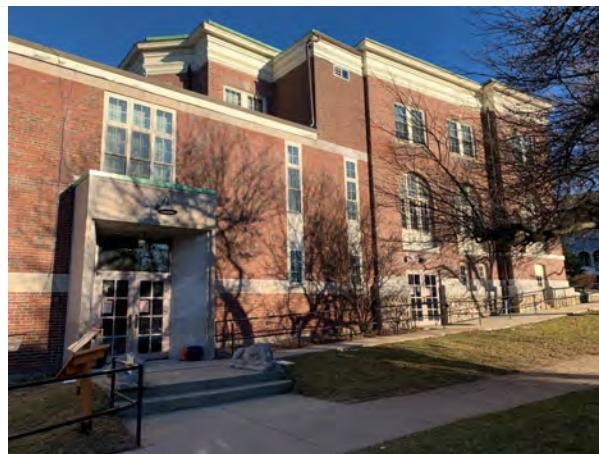
The façade of the 1966 Addition is composed of bricks of lower quality, slightly longer dimensions, and deeper red color than the Carnegie Building. Many of the bricks have pock-marks and cracks that may have been present even when they were installed. Due to the differential settlement of the foundations, cracks have opened in the mortar joints throughout the facades, allowing water to intrude into the building's exterior walls. The presence of water within these walls will propagate continued stress during seasonal freeze-thaw cycles, further degrading the facades. If a decision is made to keep the 1966 Addition for a long-term planning horizon, the open mortar joints should be repointed.

Typical brick façade condition at the 1966 Addition.

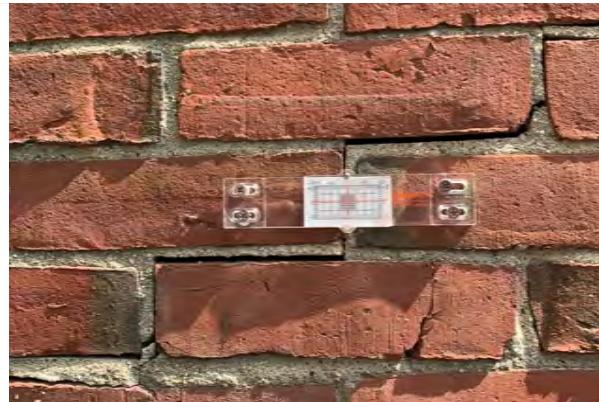
Mortar is in poor condition due to cracking at the facades of the 1966 Addition.

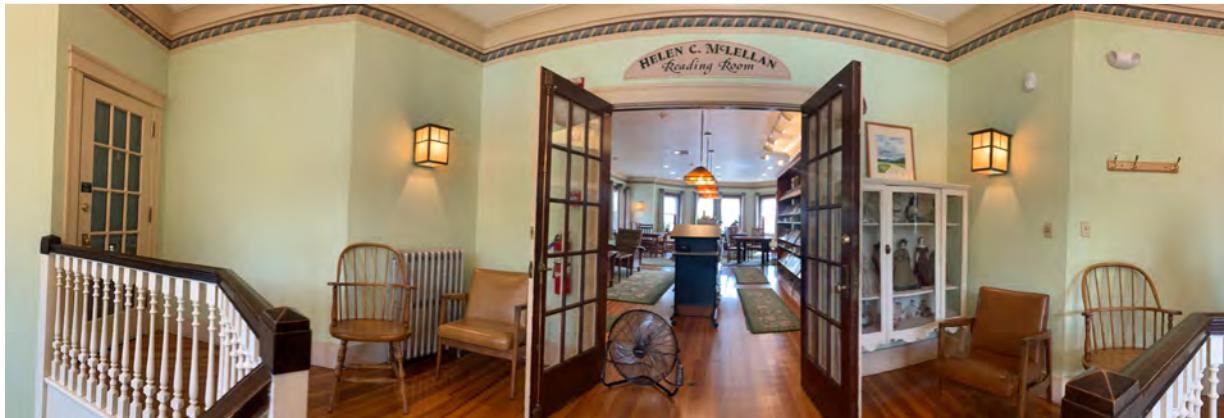
Doors on the 2nd Floor are decorative simulated divided lite doors with knob hardware. While these doors are not generally of a grade suitable for commercial use, they are presently performing without issue. The hardware on the doors should be changed to lever hardware so that these spaces are correctly accessible to persons with disabilities. Interior doors throughout the Ground Floor and 1st Floor predominantly enclose staff offices and are mostly of hollow core wood doors with knob hardware. All knob hardware should be replaced with handicap-accessible lever hardware so that staff offices are "visible" by persons with disabilities, and/or can be used by staff with disabilities.

Doors on the 2nd Floor are predominantly decorative divided-lite doors with knob hardware.

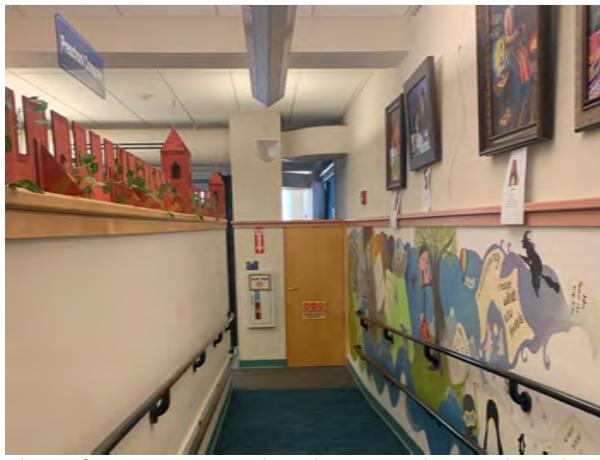
The public access door to the former civic meeting room stage, which is primarily used as a craft activities room, is not of code-compliant size. This room should be properly enclosed with bounding walls and should not be accessed via non-code-compliant doors, since fire egress is required to occur through doors and openings meeting egress code requirements.

The craft room is accessed via this non-code-compliant door at the bottom landing of the ramp in the Children's Room.

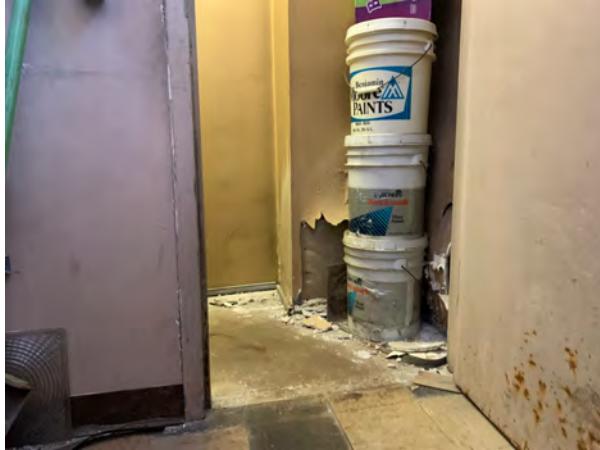
The hollow metal door to the boiler room is rusted and is typically left in the open position. This door should be replaced as soon as possible with a fire-rated hollow metal door and frame in order to safely enclose the fire hazard area of the boiler room. The rough opening of the wall surrounding this room will likely need repair in order to install the new hollow metal frame.

The exterior wall at the boiler room top stair landing is crumbling due to uneven settlement and water intrusion. The boiler room door (foreground) is rusted.

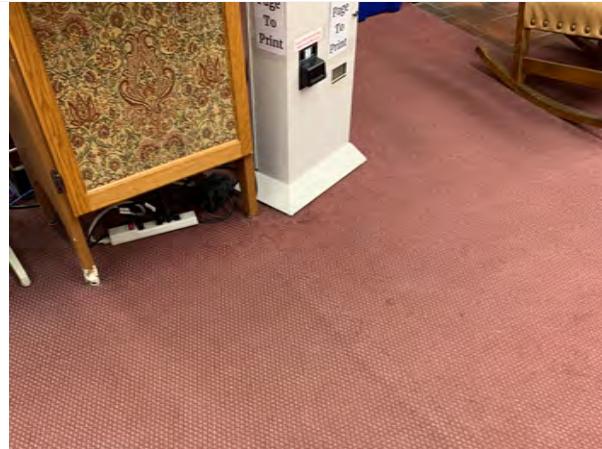
Carpeting in the 1st Floor is pilled and bare. Replacement is recommended. At time of replacement, VAT may or may not require abatement, depending on whether it is determined to be stable or friable.

Carpeting in the 1st Floor 1966 Addition is pilled and bare; replacement is recommended

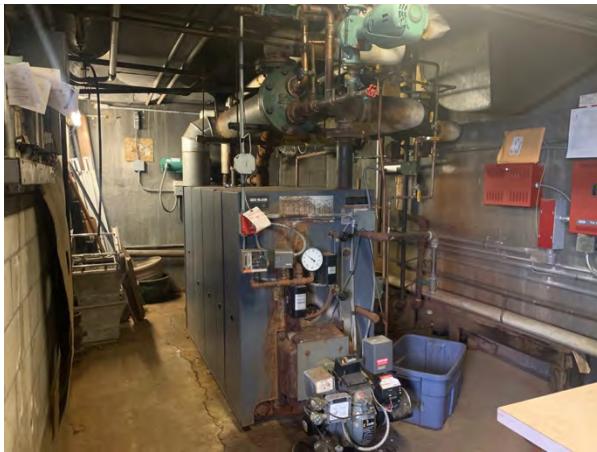
Boiler installed in 2005.

The Library is heated by an oil-fired boiler (Weil-McLain Model 80, #1080 9.6 GPD input, 1110 MBH output) that was last replaced in 2005 by Curley Plumbing & Heating. The boiler room is located below the Ground Floor at the far west down-slope side of the site. The oil tank is located in the wood-sided shed attached to the building. Based on a 10-20 year expected useful

life for a boiler, the boiler is expected to require replacement in the upcoming 5-year time horizon. The boiler is an old-style steam boiler feeding the 1966 Addition and the Ground Floor of the Carnegie Building – with an exchange heater that converts some of the steam to hot water to heat the 1st and 2nd Floors of the Carnegie Building. One radiator, a UniVent heater on the 2nd Floor in the McLellan Room, is intermittently functional and has been looked at many times. Old-style steam boiler systems tend to have high maintenance requirements, with frequent pinholes and leaks. Note that prior to the 1966 Addition, the Library got heat from the Fire Station, likely via underground hot water pipes, which are understood to have been abandoned in place.

The boiler will require replacement in the next five years. Curley Plumbing & Heating, the Town's long-term service company, recommends replacing all of the steam heating distribution piping that has caused numerous leaks. Steam generated by the boiler is also converted to water to feed the front half of the heating supply locations in the building, which is an energy-inefficient system design. All piping and heating radiators should be hot water piping.

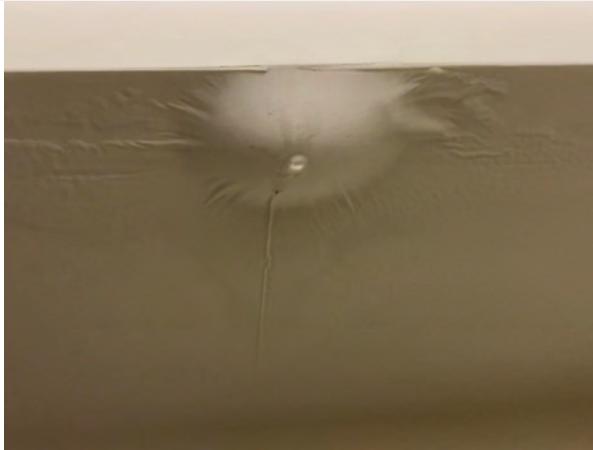
The steam pipe cracking/bursting in 2021 and 2024 occurred in the ceiling of the south side of the Ground floor, where the steam pipes are hung in a soffit along the perimeter of the building. In both cases the cracking/bursting occurred in the soffit located directly in front of the elevator. A complete renovation of the area in front of the circulation desk and an adjacent collections area resulted from the 2021 pipe burst.

Contractors and facilities personnel provided comment that the age of the steam pipes alone is not sufficient to explain the extent of cracks and leaks in the steam pipes. The uneven settlement of the concrete foundations, floor slabs, and pipe chases is suspected to have created stresses on the pipes and pipe joints that are hung by metal pipe hangers attached to building's structure.

Steam pipe leak at Ground Floor elevator soffit, February 2024 – showing one of three locations where the soffit was bulging.

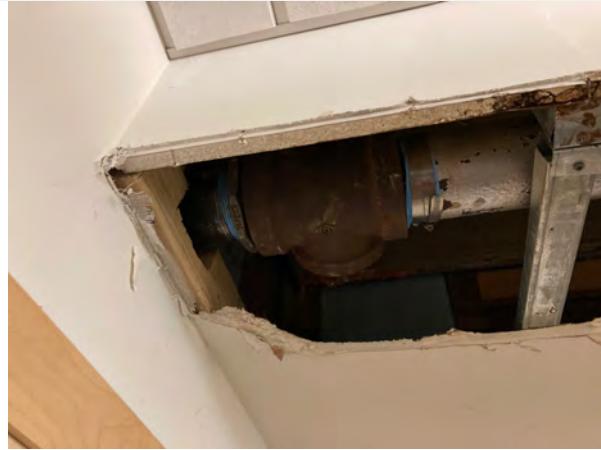
Steam pipe leak at Ground Floor elevator soffit, February 2024.

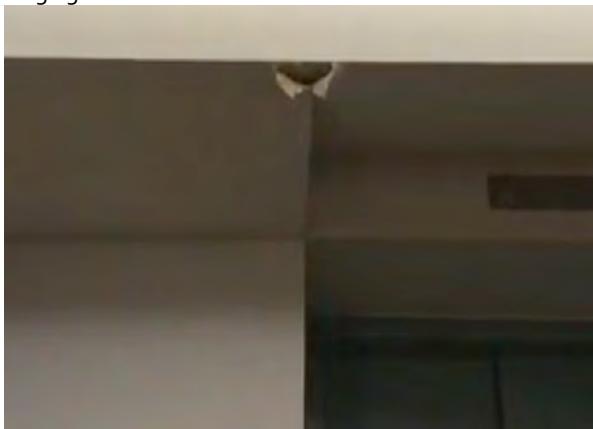
Steam pipe leak at Ground Floor elevator soffit, Spring 2021.

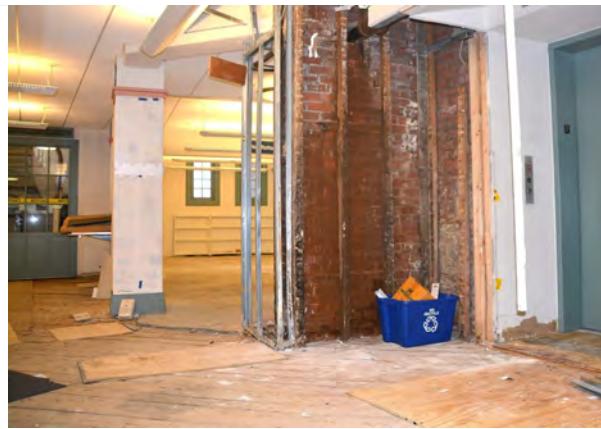
Repairs to Children's Room after steam pipe leak at Ground Floor elevator soffit, Spring 2021. *Photo credit Ed Karvoski Jr., Community Advocate*

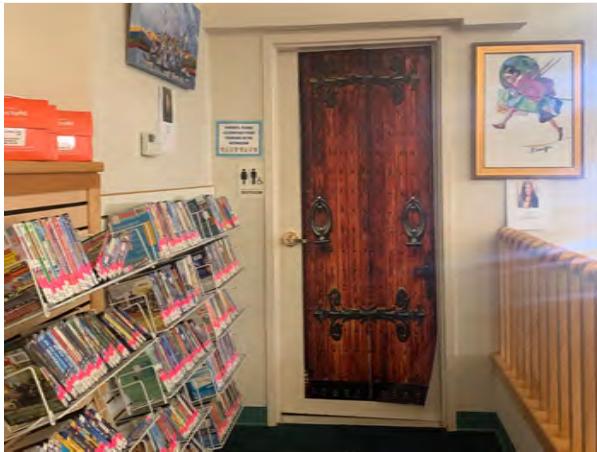
Handicap-accessible restroom does not have sufficient push-side clearance at the entrance to the room and is therefore not code compliant.

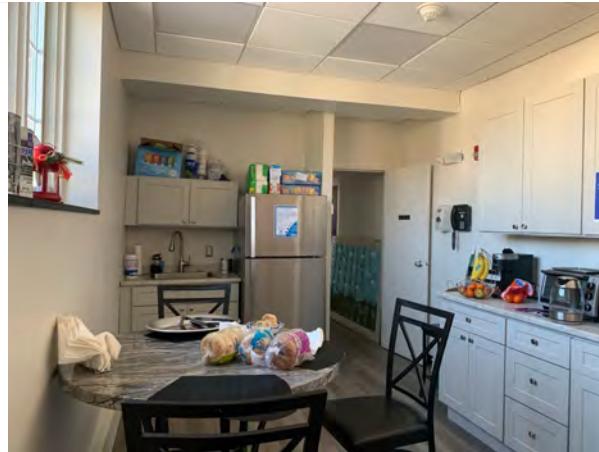
The staff kitchen was renovated following an April 2023 steam pipe leak that destroyed the finishes in this area and the adjacent hallway and bathroom.

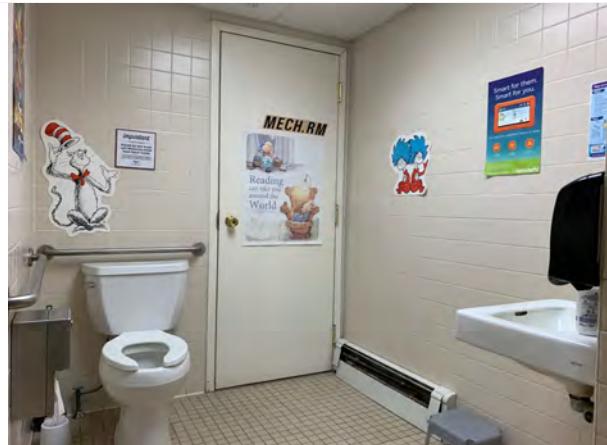
Handicap-accessible restroom has water accumulation below the tile floor due to the toilet repeatedly overflowing.

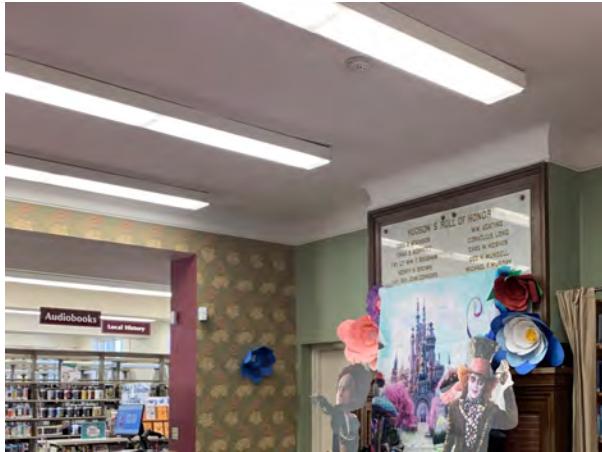
Most 1st and 2nd Floor lighting has been converted to LEDs. Image shows lights on the 1st Floor near the reference desk.

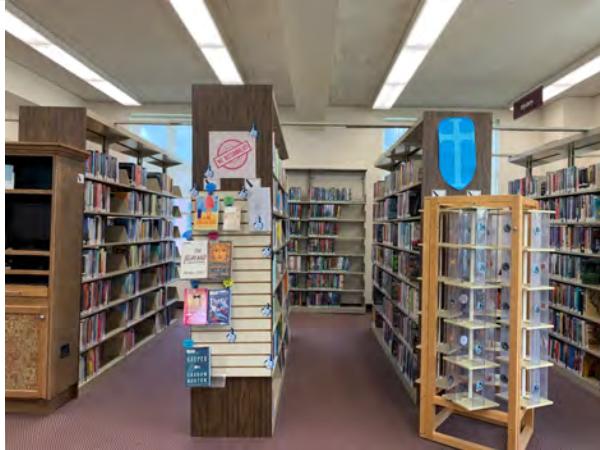
End-cap casework on the 1st Floor is out-of-date and of multiple unmatched styles.

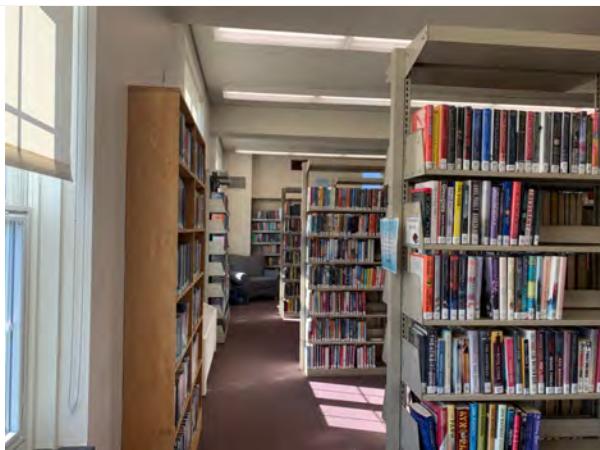
Structural Engineer Tripi Engineering has advised the Library that the number of books in the collections shelving area of the 1966 Addition 1st Floor must be decreased in order to reduce the weight of the book dead load, since the area was designed as a "reading room" and not as a collections area. Furthermore, Tripi advised the Library that book stacks cannot be rotated 90-degrees to improve sight lines from the circulation and reference desk, since the stacks currently span between floor joists, which is required in order for the floor to continue to support their weight.

Metal shelving on the 1st Floor violates building code due to the weight of its contents; the floor diaphragm was designed for a "Reading Room" not a "Collections Room."

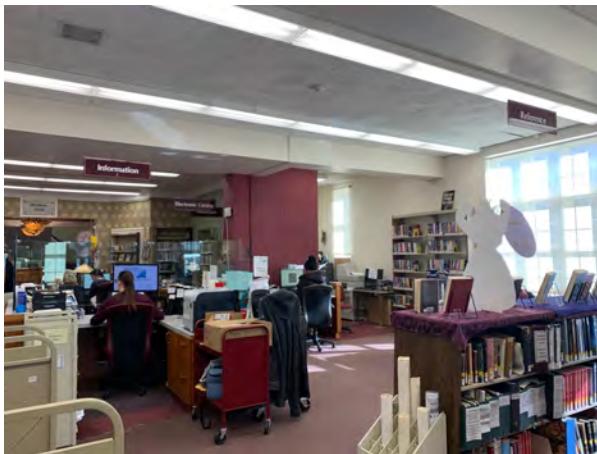
The Information Desk casework on the 1st Floor is not of durable quality and lacks space for parking book trucks.

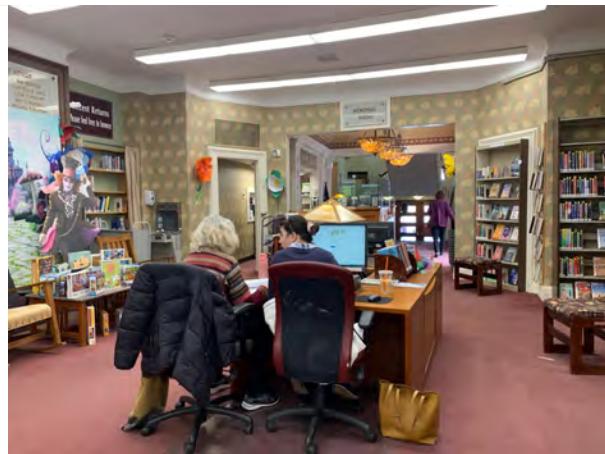
Desks used for tutoring on the 1st Floor are conventional office desks.

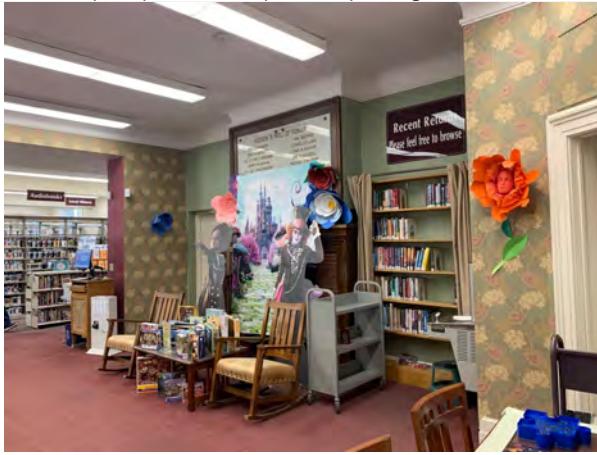
1st Floor furniture is a mix of antique and contemporary items not purpose designed for their use or location.

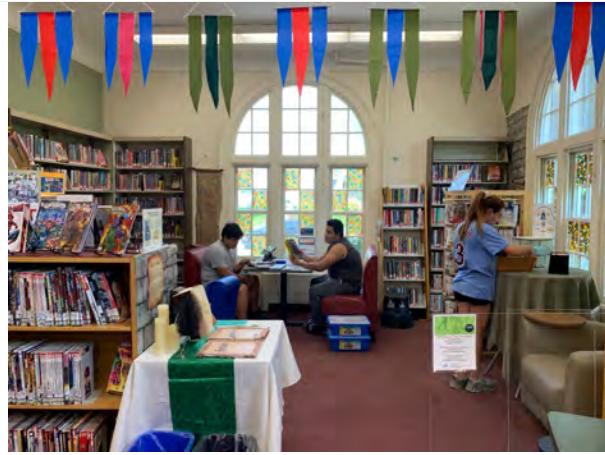
Furniture in the teen area on the 1st Floor is uncoordinated and out-of-date.

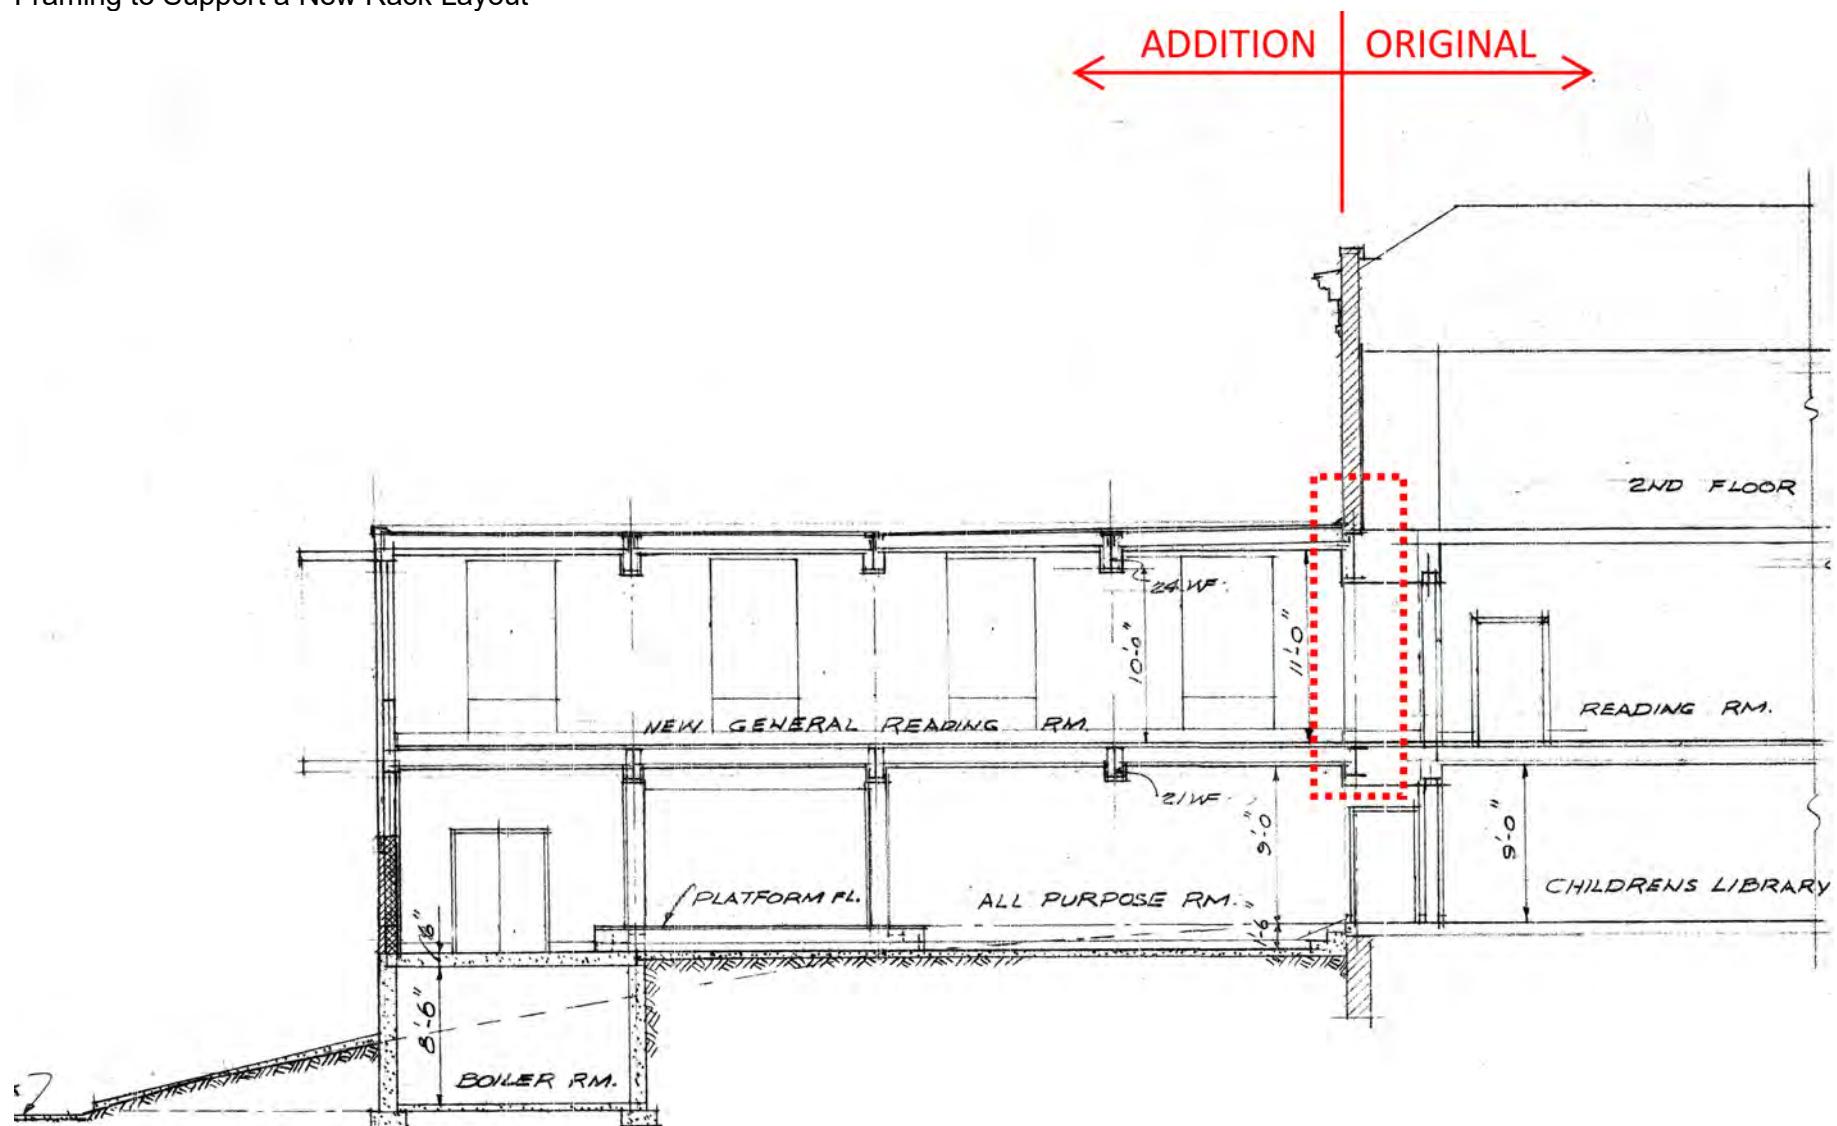
Figure 2 – Cross section of building showing “junction” between Addition and Original Building.

4. Investigation of the type / condition of the connections between structural elements at the junction between the Addition and Original Building (Figure 2) revealed that the connections are generally bearing-type connections, which can accommodate some additional movement without being overstressed, however, significant additional movement could lead to instabilities and related structural failure. One of the connections observed at the northwest stairwell should be supplemented / strengthened to safely accommodate the anticipated additional movement.
