Conditions Assessment, 15 May 2024

Hudson Public Library

Hudson, MA

Prepared by: Sorensen Partners | Architect + Planners, Inc., Westborough, MA
For: Hudson Public Library, Hudson, MA
Owner: Town of Hudson, MA

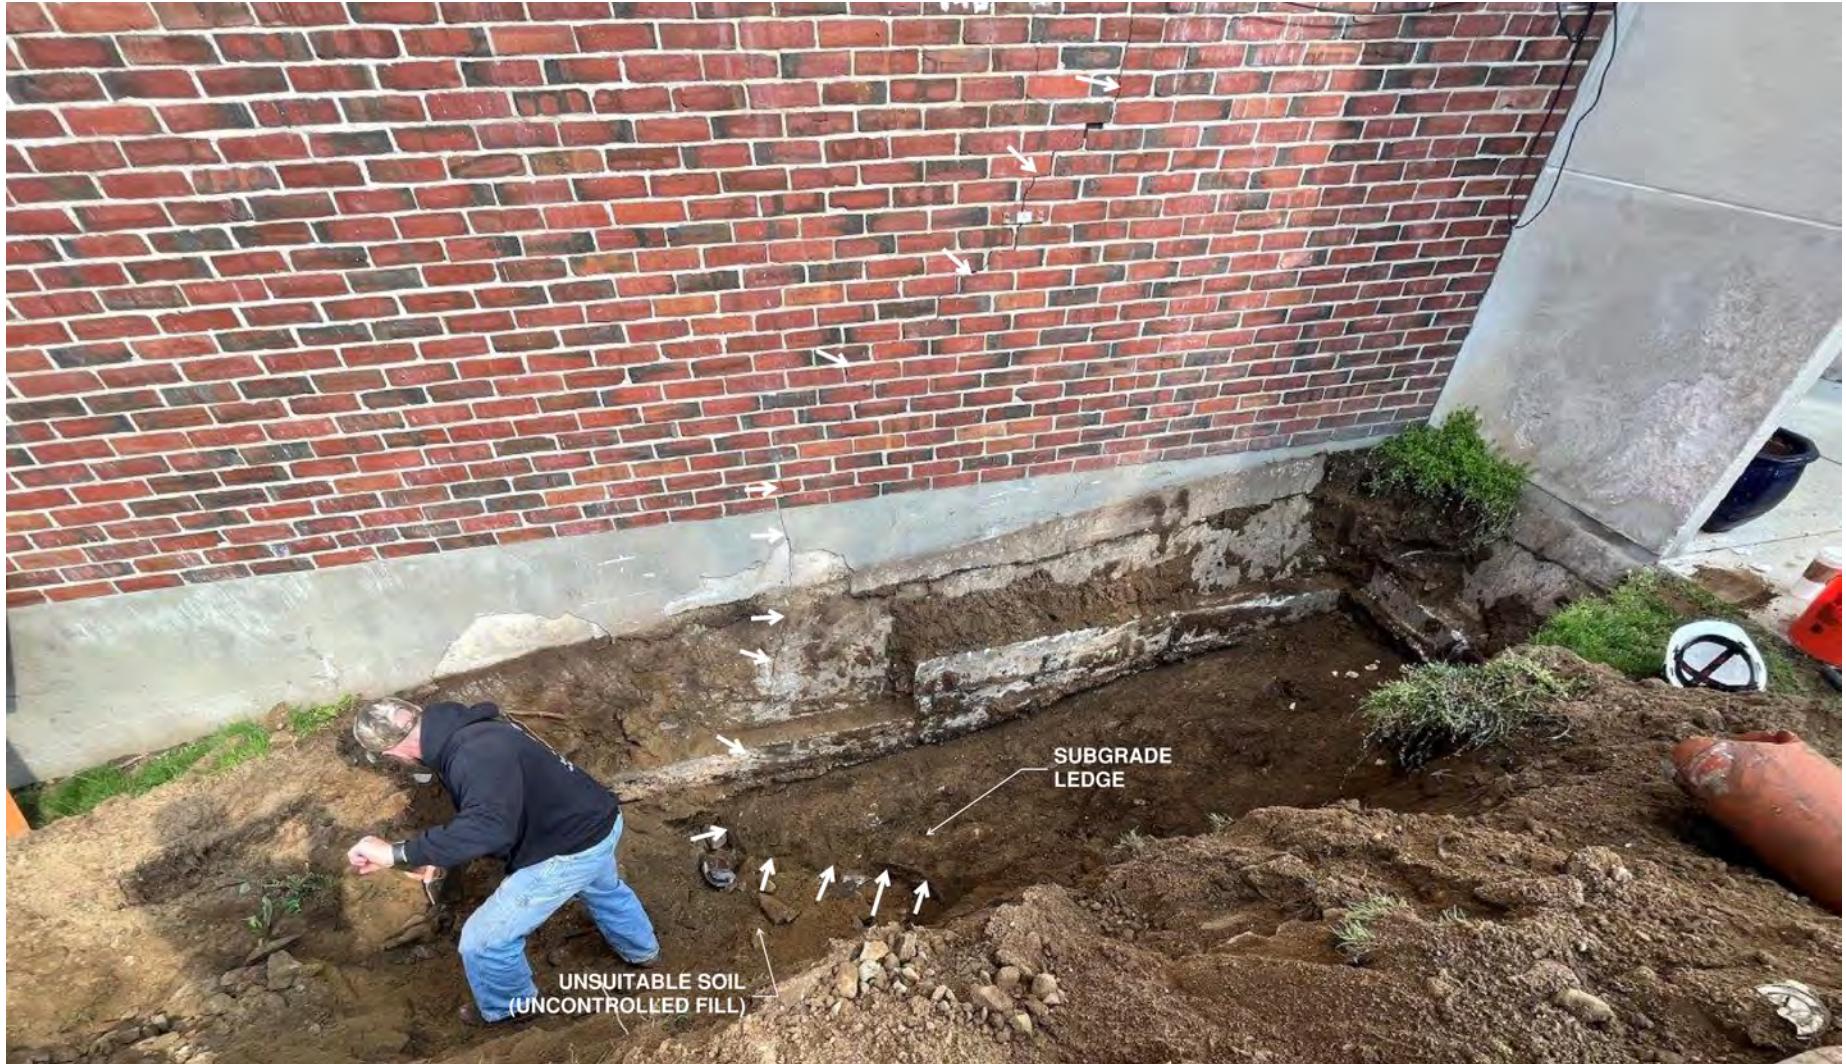
Figure 3 – Photograph from test pit on southeast side of Addition.

5. Geotechnical / subsurface investigation revealed that the portions of the Addition observed to have settled are generally founded on unsuitable soil, while the Original Building and other portions of the Addition appear to be founded on “rock ledge” and / or suitable soil.

Figure 3 shows an abrupt “drop off” of the rock ledge beneath a portion of the Addition that corresponds to the location of one of the most significant cracks in the brick veneer. A direct pathway can be observed (white arrows in Figure 3) from the edge of the ledge below grade to the crack in the building’s exterior brick veneer.

6. Potential options for providing supplemental support to stabilize the foundation and mitigate further movement explored to date include a) “pit underpinning” with concrete, b) installation of “drilled minipiles,” and c) installation of “resistance piers.” Each approach has pros and cons, and all three have potential limitations.

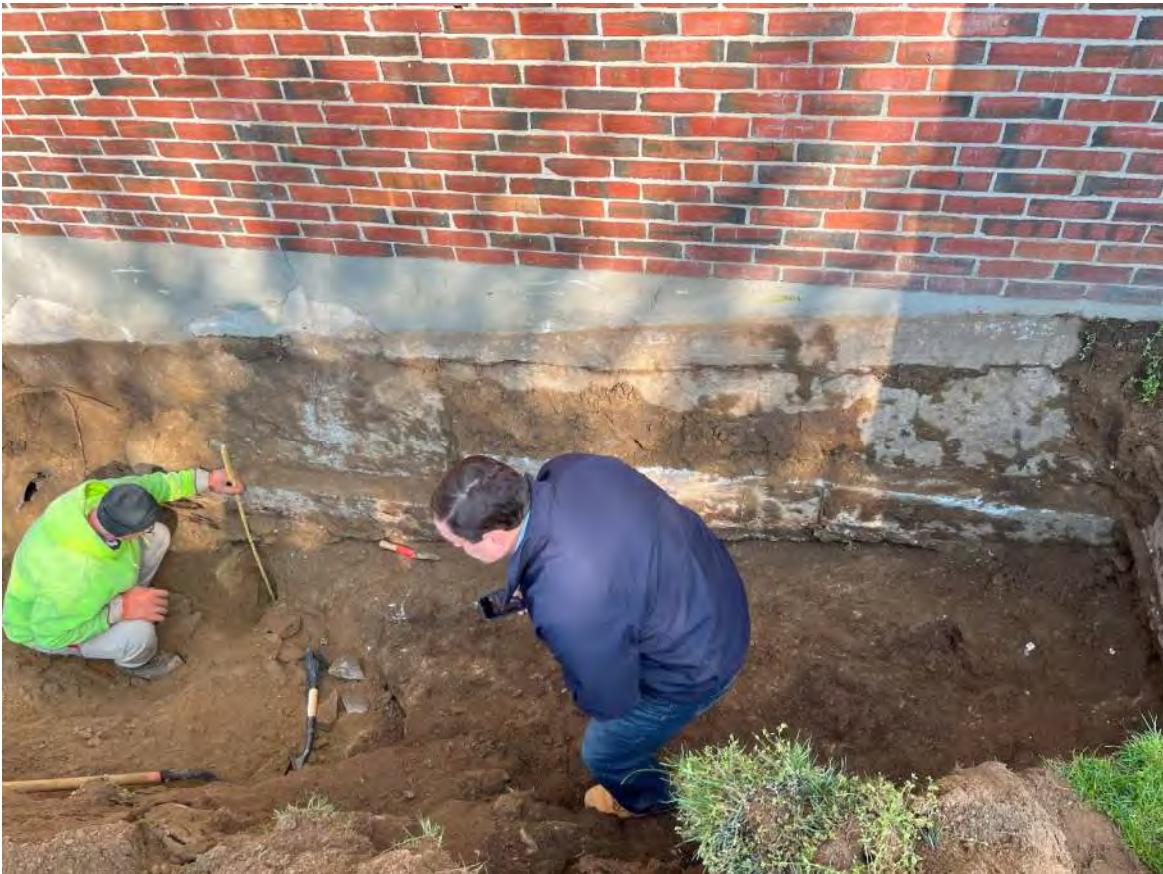
**Test Pit TP-1 Excavation,
Looking West.
Note the edge of exposed
bedrock.**

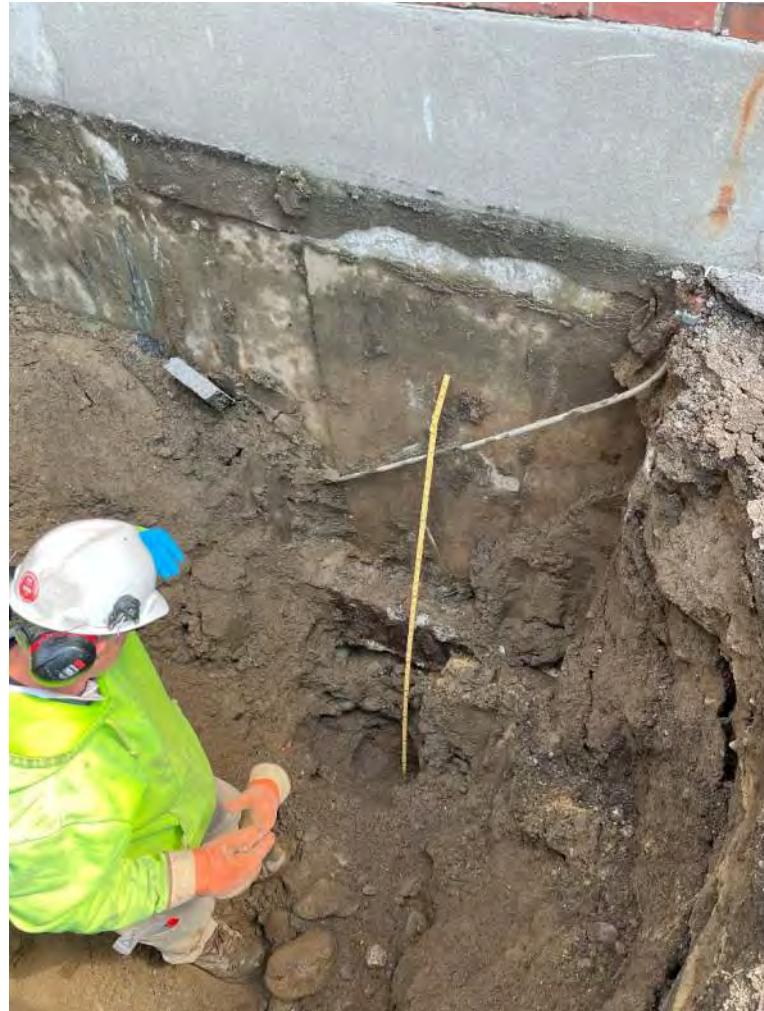
**Test Pit TP-2 Excavation, Looking East.
Note exposed bottom of footing bearing within the fill layer.**

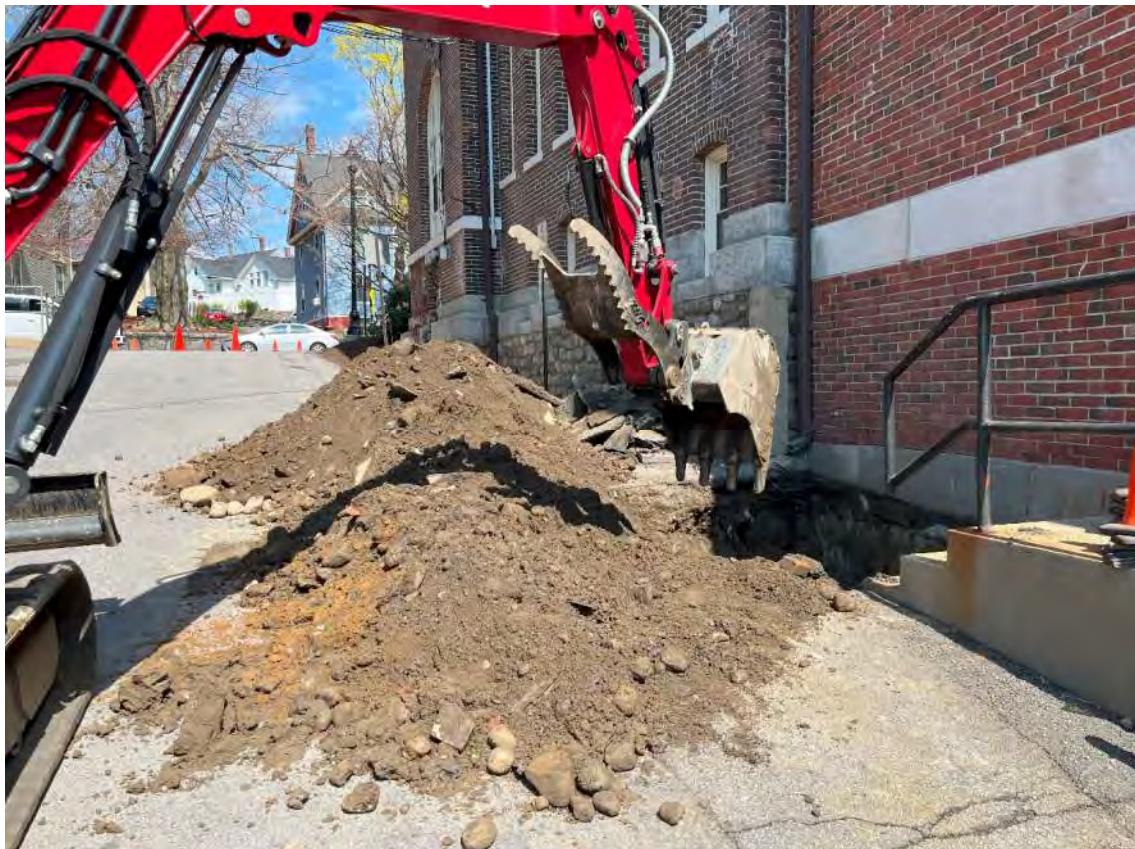
**Test Pit TP-2 Excavation, Looking Northeast.
Note the quantity of cobbles and boulders within the uncontrolled
fill.**
